Condominiums at Paradise Shores Long Term Maintenance Report

July 21, 2025

J. Scott Rasbach, Maintenance Director

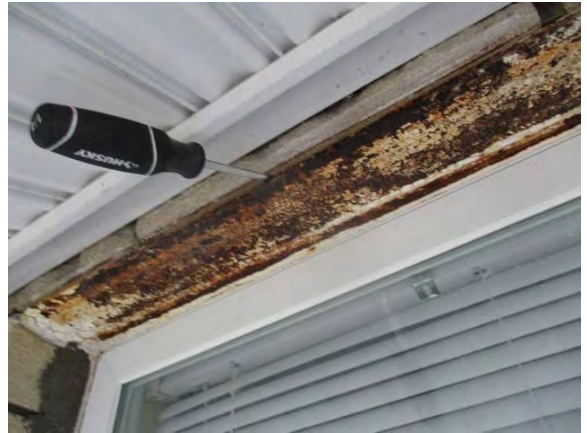
The deficiency observed is due to sagging or deflected metal lintels on the first floor, which have resulted in cracking within the fluted concrete block directly above these structural members. This failure has extended to the second floor, where noticeable and severe separation has occurred at certain window locations where the frames meet the block construction. Upon closer inspection, many of the affected lintels were found to exhibit heavy corrosion, including laminar (or stratified) corrosion—a condition where rust causes the steel to flake or separate in layers, significantly reducing the section size and compromising structural performance.

5 Front Left Lintel Sag w/ Severe Corrosion

For the lintels and adjacent masonry areas that are heavily damaged, Beryl recommends that temporary shoring be installed to safely support the structure above during repairs. Once shoring is in place, the damaged fluted block or brick masonry surrounding the lintels should be carefully removed. The corroded lintels should then be extracted and replaced with new corrosion-resistant

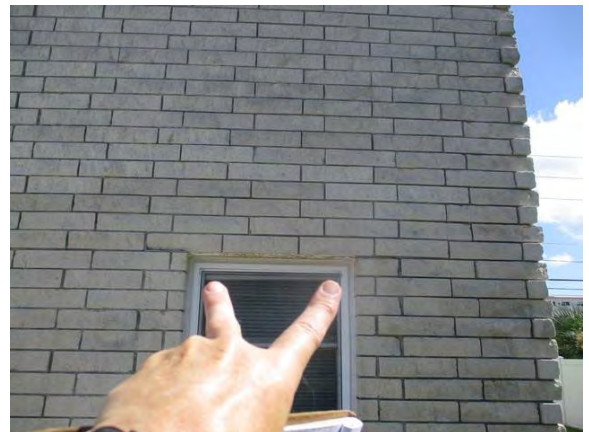
13 Front Right Lintel Sag w/ Severe Corrosion

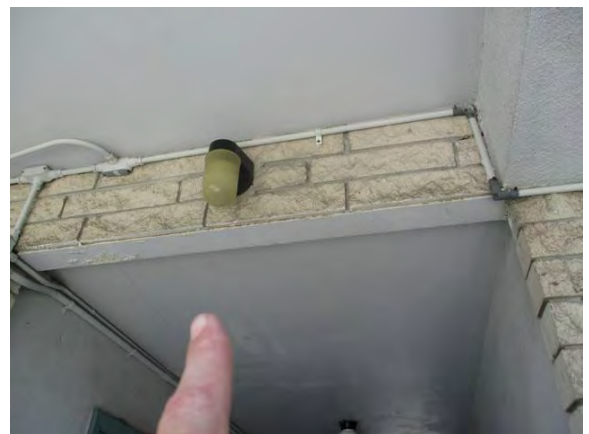
15 1st Floor Walkway Lintels Minor Corrosion

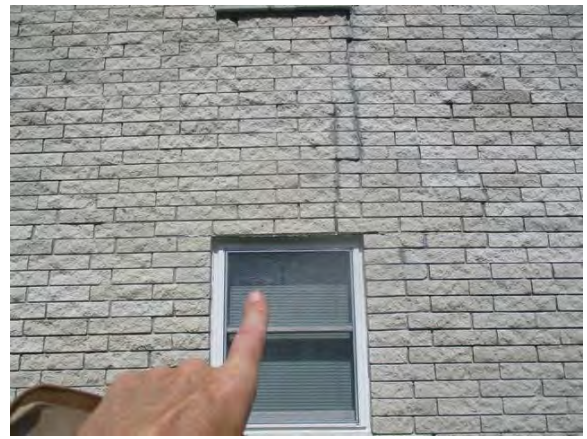
17 Hallway Lintel Minor Corrosion/Peeling Paint

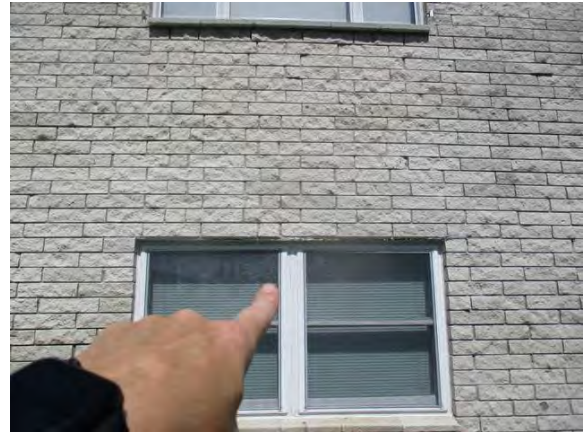
19 Right Side of Building Fluted Block Cracked Between 1st & 2nd Floors

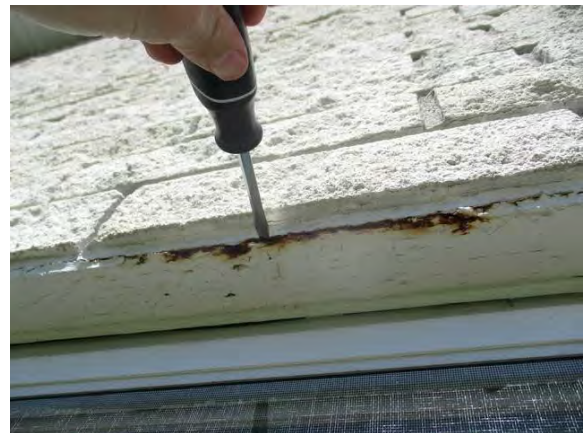
21 Right Side of Building Lintel Sag w/ Severe Corrosion

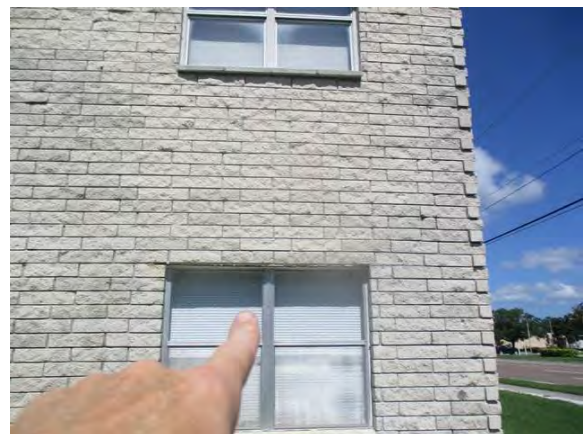
23 2nd Floor Lintels Minor Corrosion

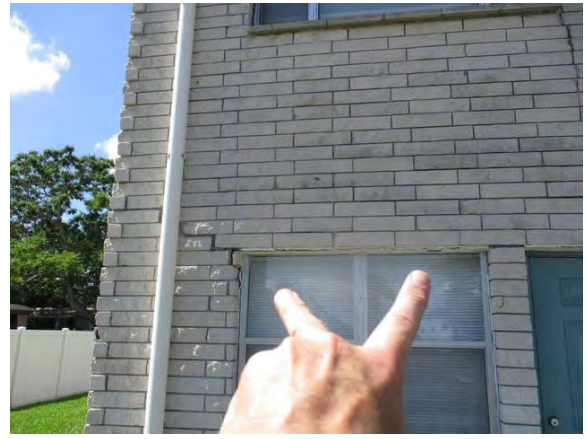
25 Right Side of Building Lintel Sag w/ Severe Corrosion

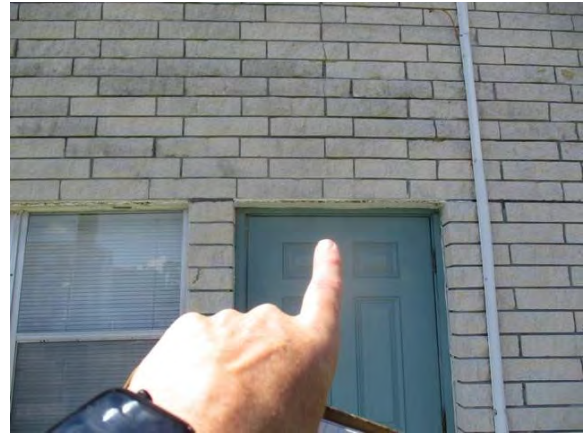
27 Rear of Building Lintel Sag w/ Severe Corrosion

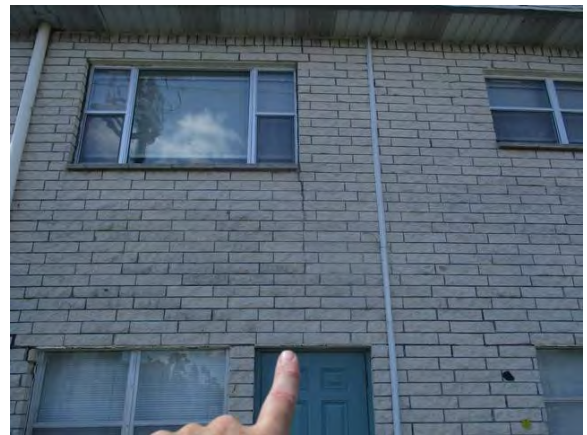
29 Rear of Building Lintel Sag w/ Severe Corrosion

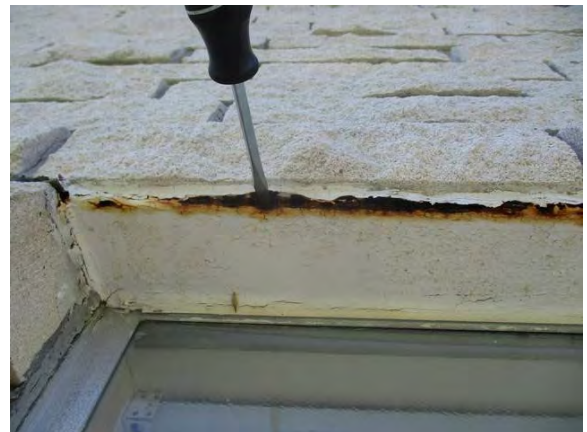
31 Rear of Building Lintel Sag w/ Severe Corrosion

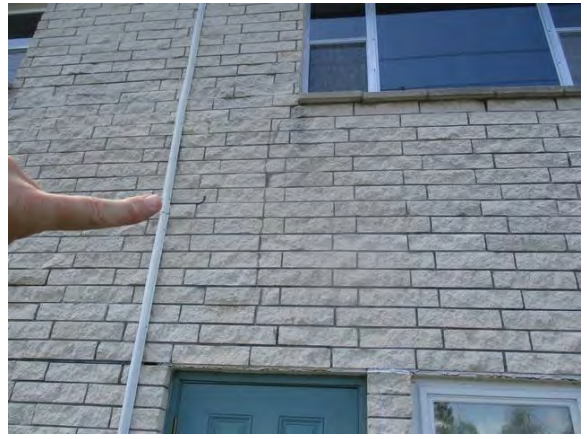
33 Rear of Building Fluted Block Cracked Between 1st & 2nd Floor

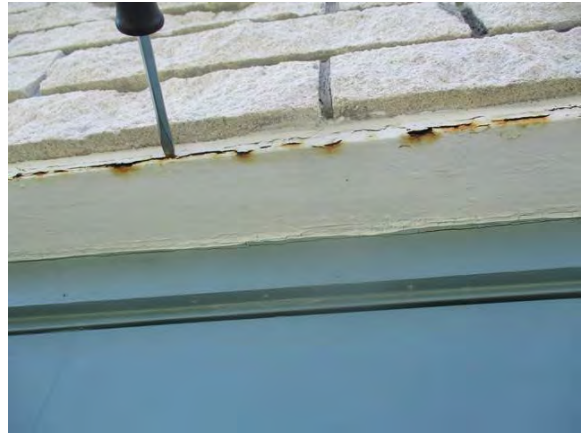
35 Rear of Building Lintel Sag w/ Severe Corrosion

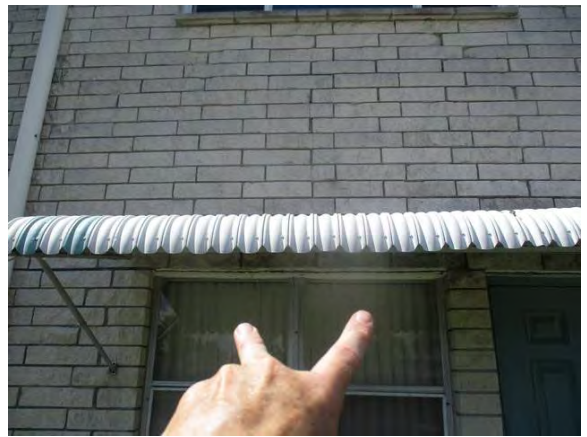
37 Rear of Building Fluted Block Cracked Between 1st & 2nd Floor

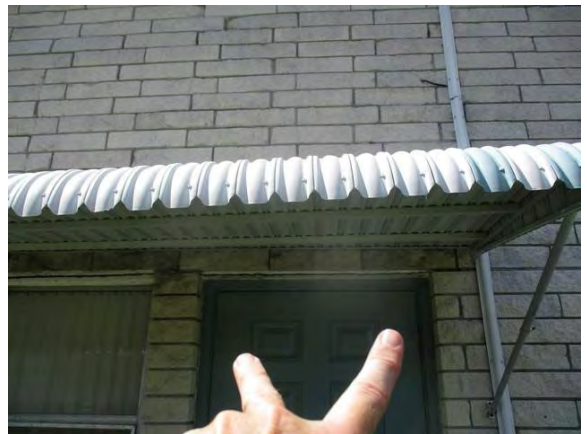
39 Rear of Building Lintel Sag w/ Severe Corrosion

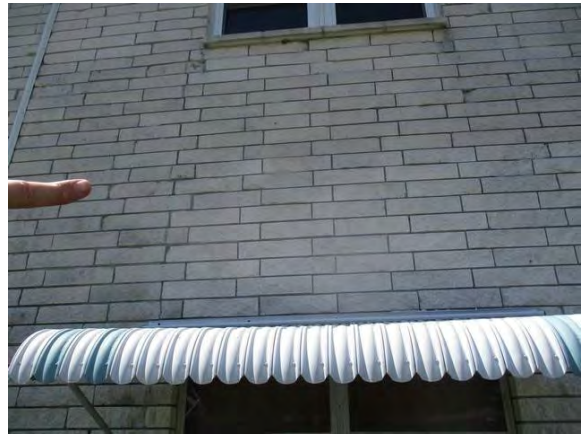
41 Rear of Building Lintel Sag w/ Severe Corrosion

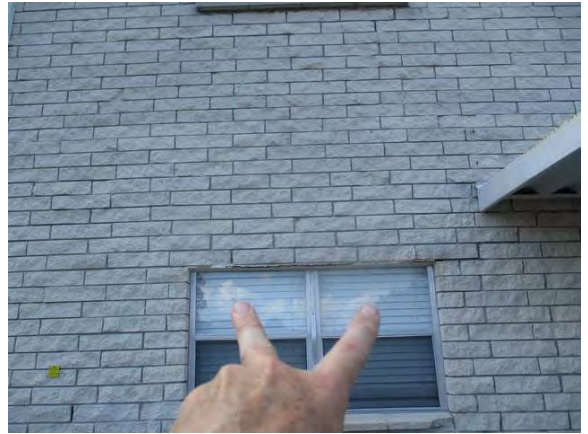
43 Rear of Building Fluted Block Cracked Between 1st & 2nd Floor

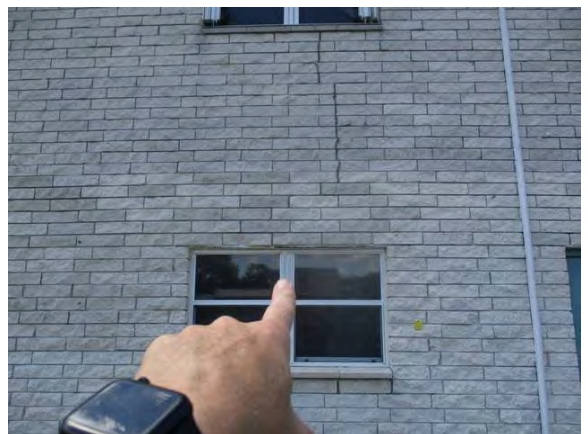
47 Rear of Building Fluted Block Cracked Between 1st & 2nd Floor

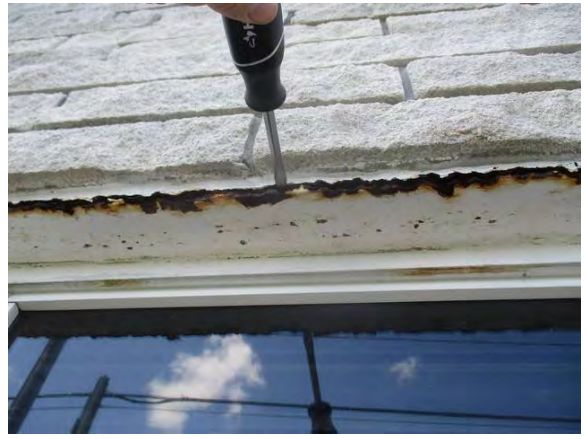
49 Rear of Building Lintel Sag w/ Severe Corrosion

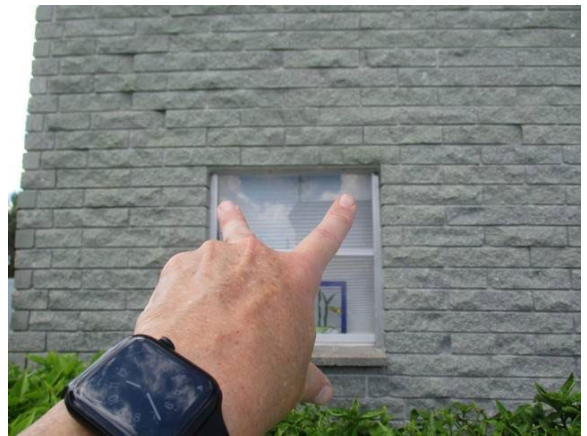
5 2nd Floor Lintels Minor Corrosion

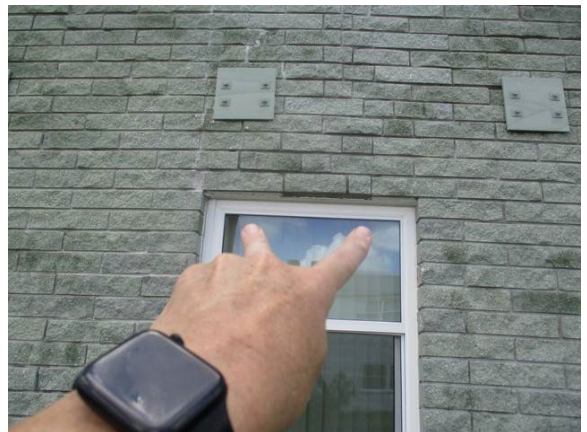
13 Front Right Fluted Block Cracked

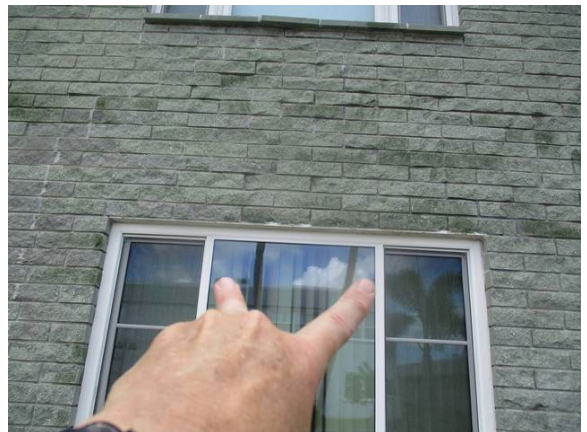
15 Right Side of Building Fluted Block Cracked Between 1st & 2nd Floors

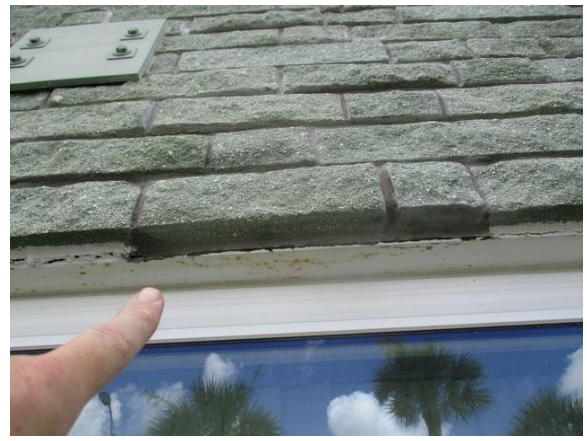
17 Right Side of Building Fluted Block Cracked Between 1st & 2nd Floors

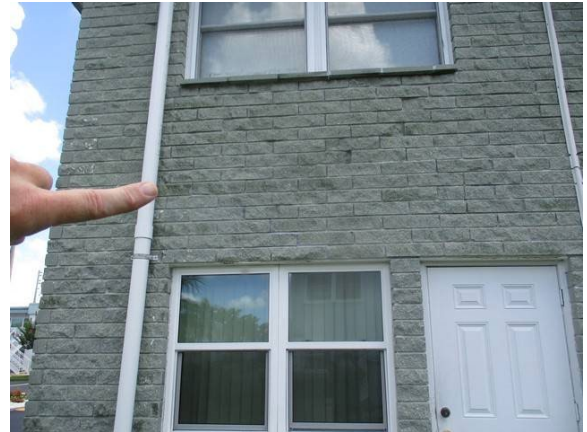
19 Rear of Building Lintel Sag w/ Severe Corrosion

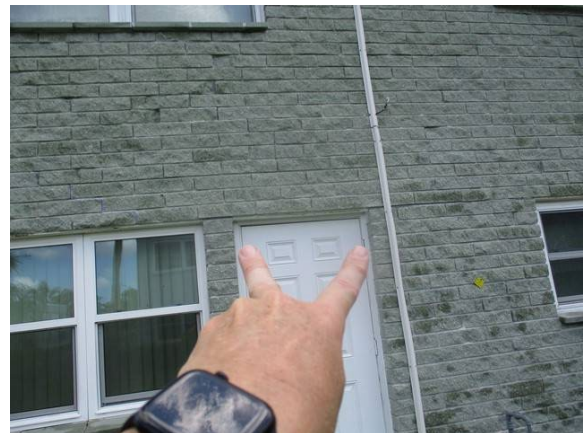
21 Rear of Building Lintel Sag w/ Severe Corrosion

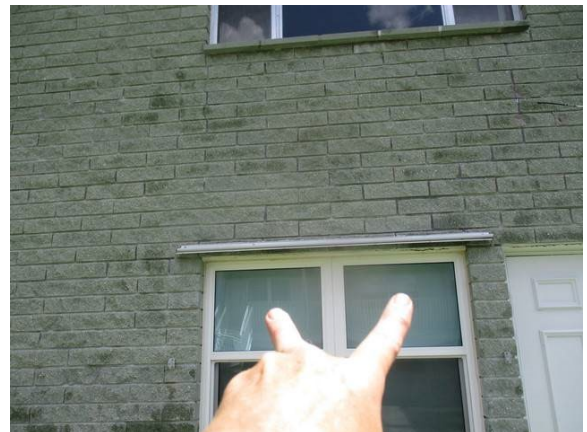
23 Rear of Building Fluted Block Cracked Between 1st & 2nd Floors

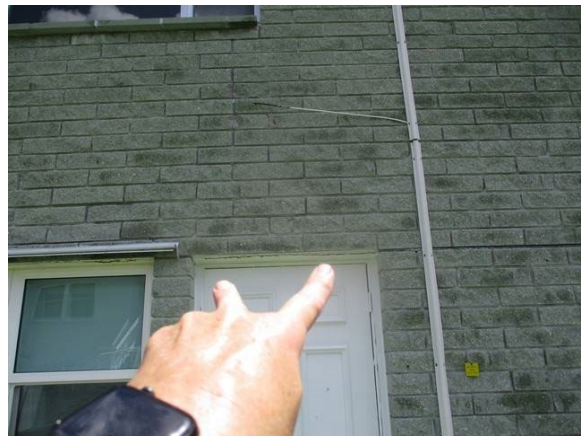
25 Rear of Building Fluted Block Cracked Between 1st & 2nd Floors

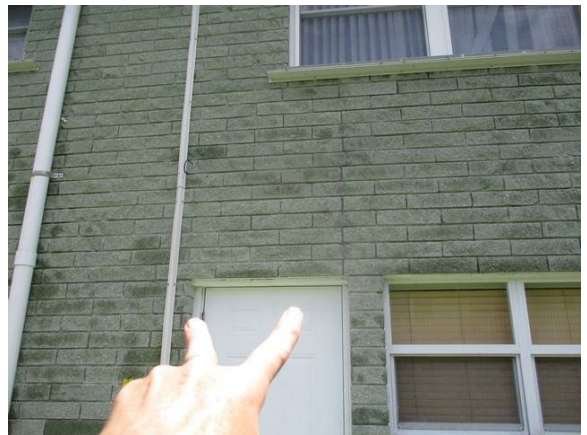
29 Rear of Building Lintel Sag w/ Severe Corrosion

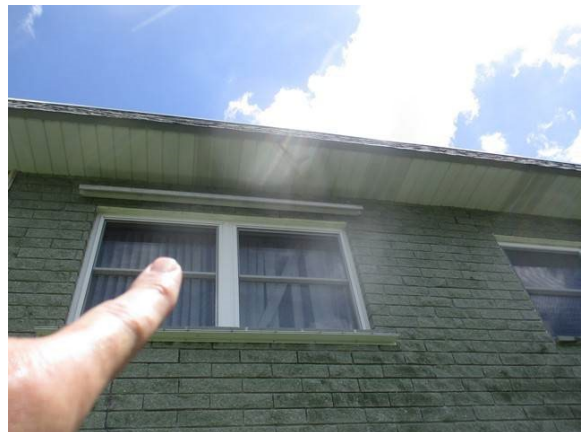
31 Rear of Building Lintel Sag w/ Severe Corrosion

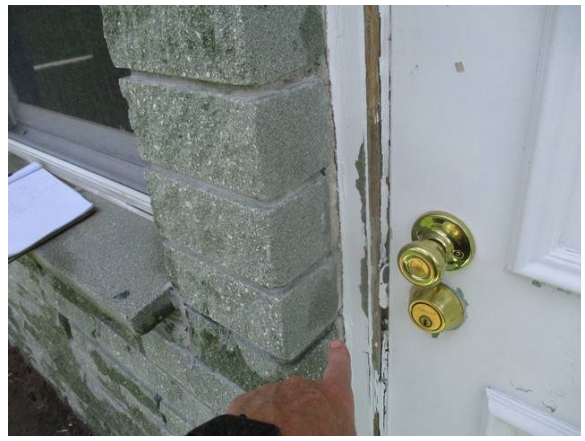
33 Window Caulking Deteriorated/Missing Throughout

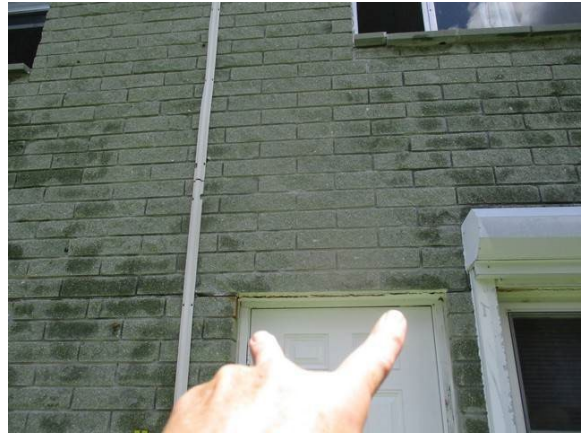
35 Rear of Building Lintel Sag w/ Severe Corrosion

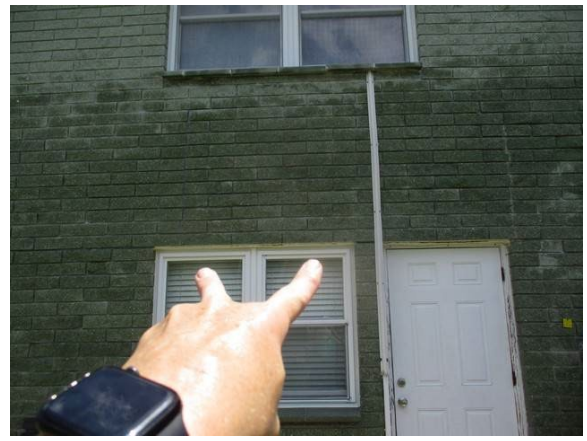
41 Hallway Lintel Minor Corrosion

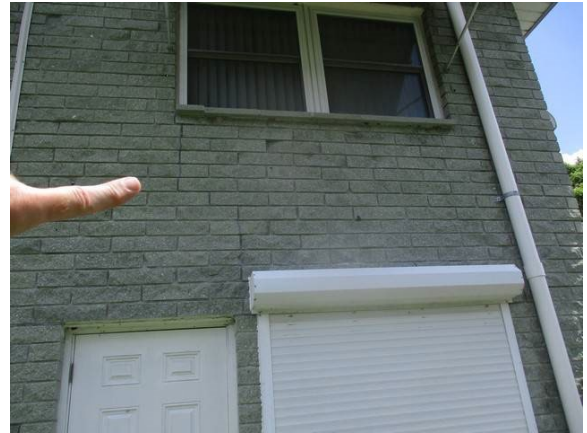
43 Rear of Building Fluted Block Cracked Between 1st & 2nd Floors

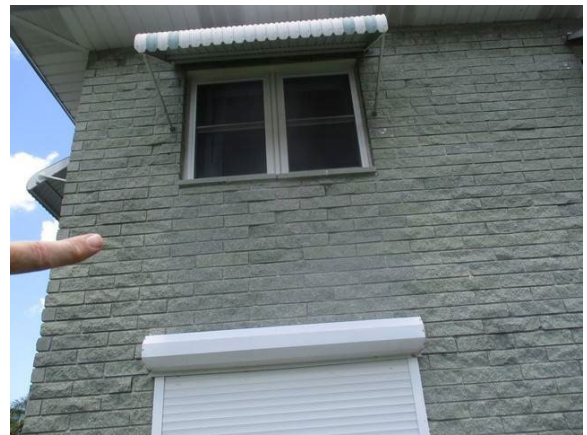
45 Unable To Inspect Rear Left Lintel Due To Roll Down Shutters

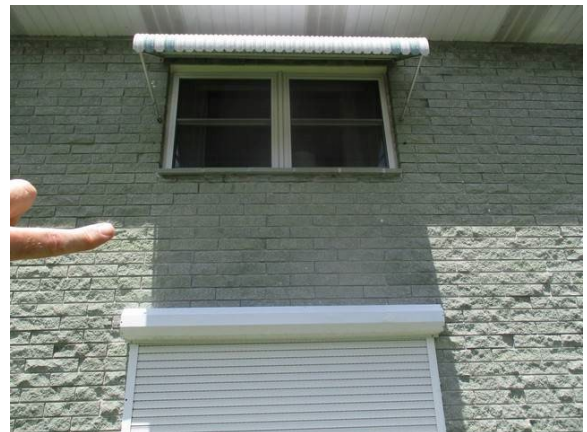
47 Left Side of Building Unable To Inspect Lintels Due To Roll Down Shutters

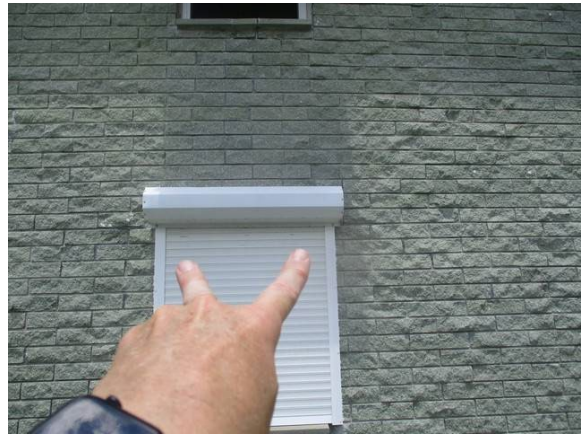
49 Left Side of Building Fluted Block Cracked Between 1st & 2nd Floors

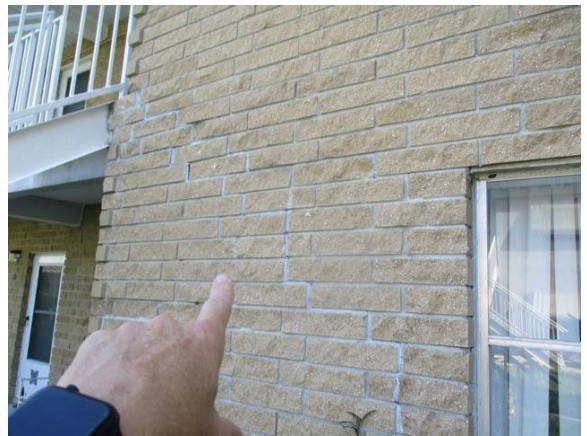
5 Front Right #13 Lintel Sag

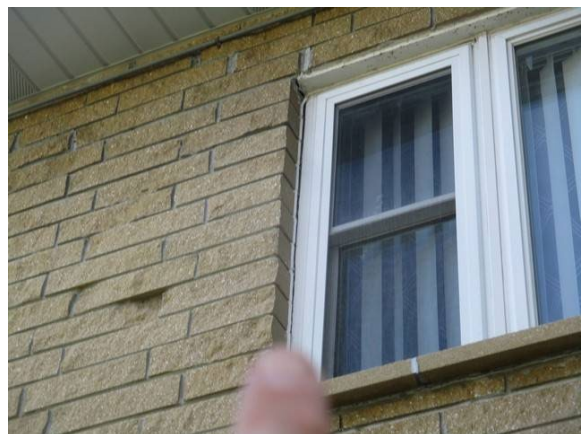
7 2nd Floor Lintel Minor Corrosion

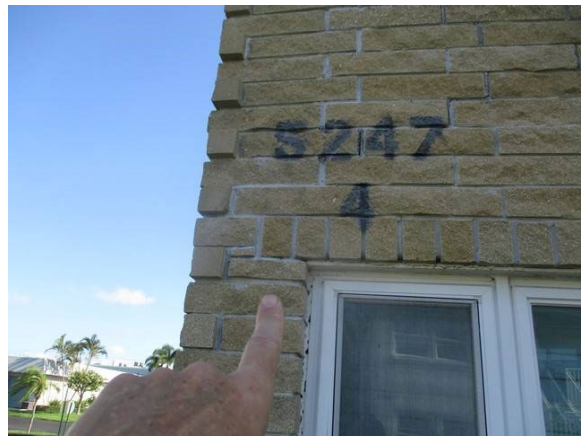
13 Front Left Lintel Sag w/ Excessive Corrosion Fluted Block Cracking

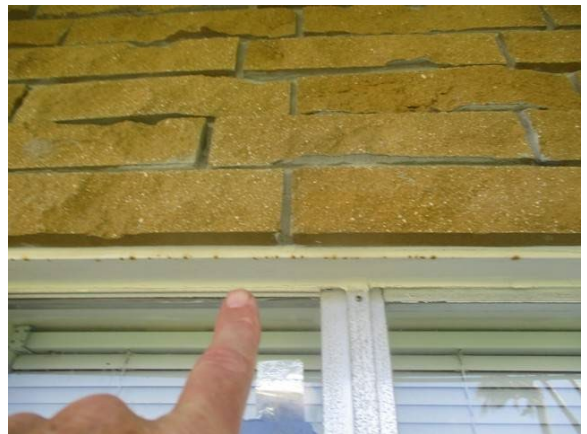
15 Front Left 2nd Floor Window Separation

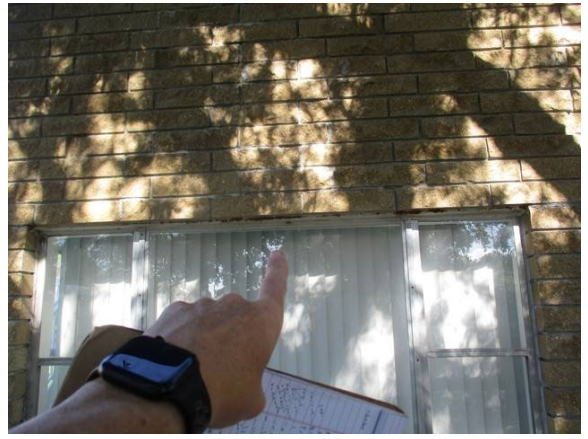
17 Right Side 1st Floor Lintel Severe Corrosion

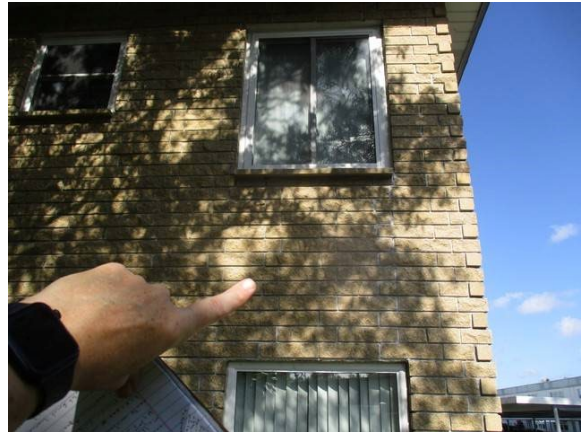
21 Right Side 1st Floor Lintel Severe Corrosion w/ Sag

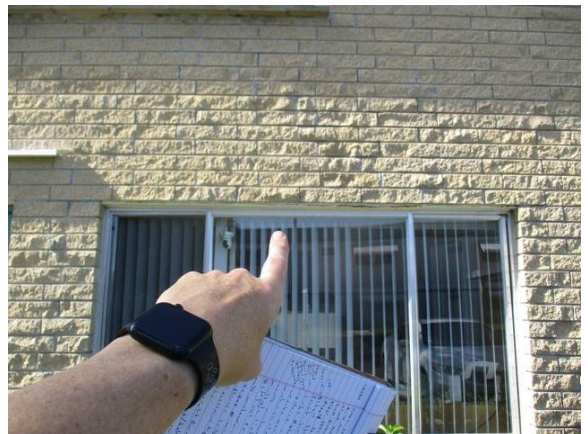
23 Right Side 1st Floor Lintel Severe Corrosion

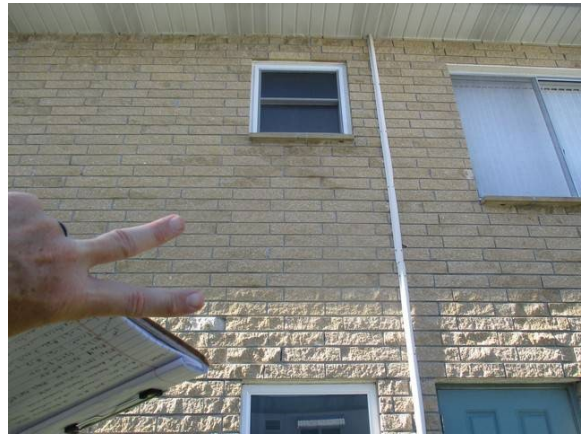
25 Rear of Building Lintel Severe Corrosion w/ Sag

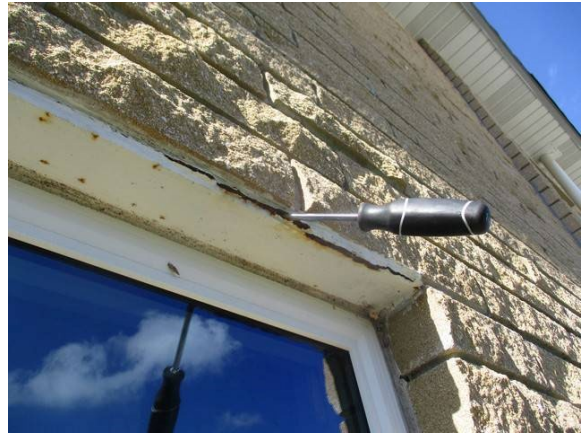
27 Rear of Building Lintel Severe Corrosion w/ Sag

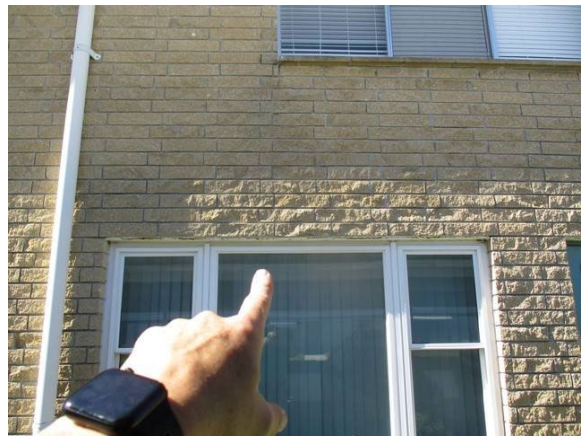
29 Rear of Building Lintel Severe Corrosion w/ Sag

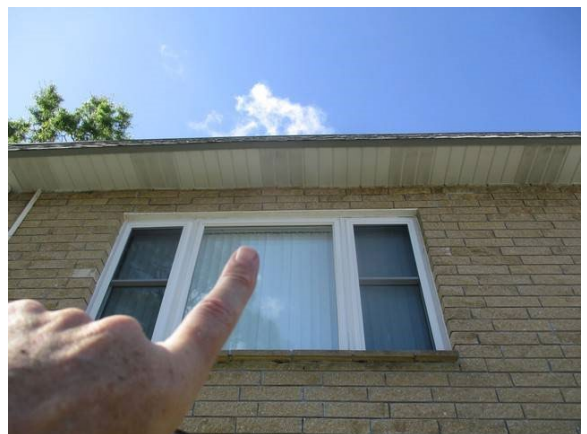
31 Rear of Building Lintel Severe Corrosion w/ Sag

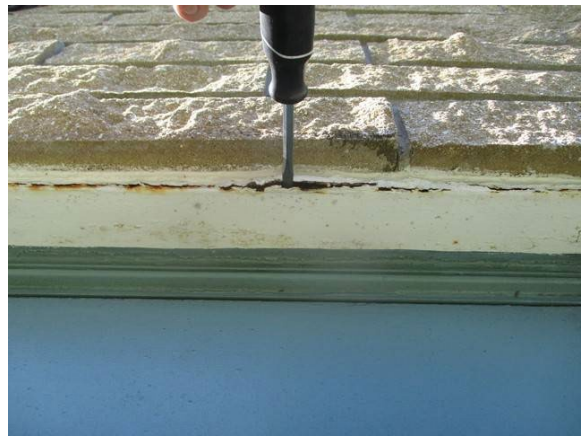
33 Rear of Building Lintel Severe Corrosion w/ Sag

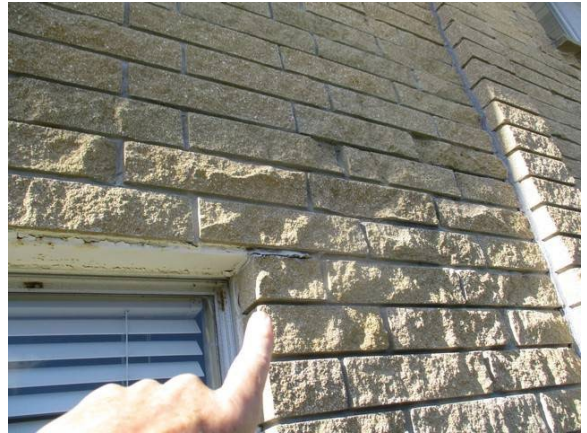
35 Rear of Building Lintel Sag

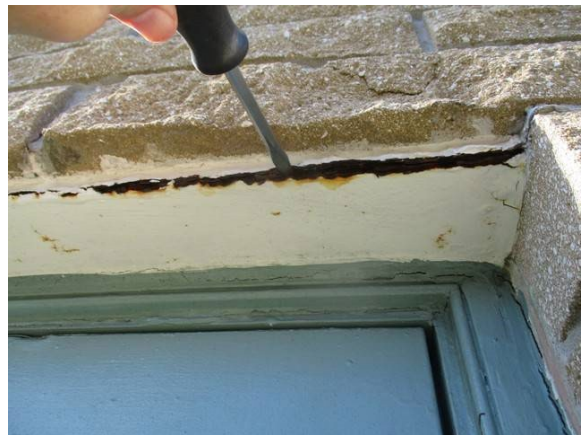
37 Rear of Building Lintel Sag w/ Severe Corrosion

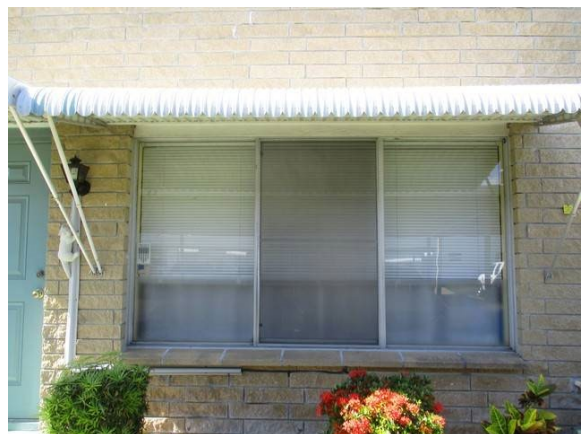
39 Rear of Building Lintel Sag

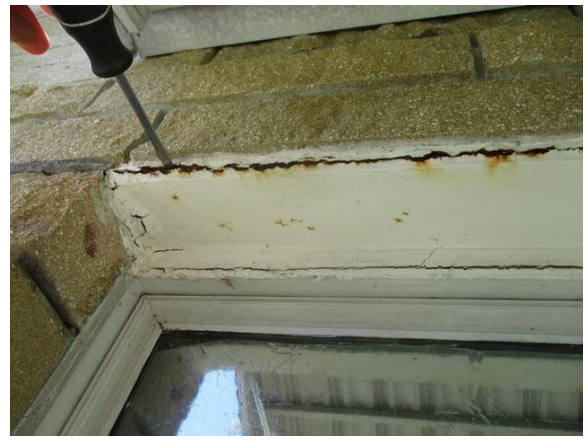
41 Rear of Building Lintel Sag w/ Severe Corrosion

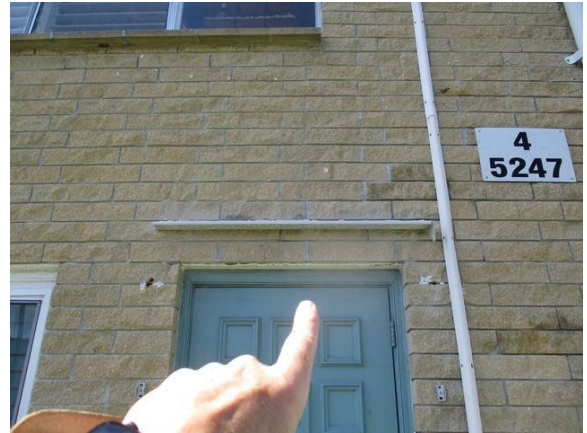
43 Rear of Building Lintel Sag w/ Severe Corrosion

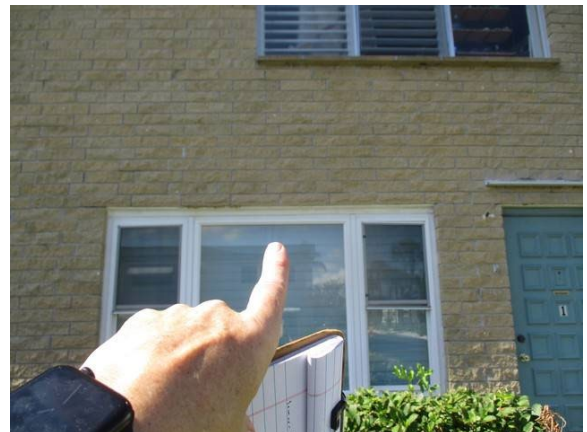
45 Rear of Building Lintel Sag w/ Severe Corrosion

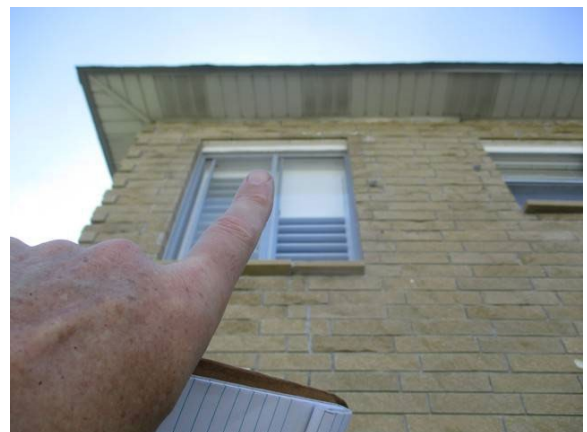
47 Rear of Building Lintel Sag w/ Severe Corrosion

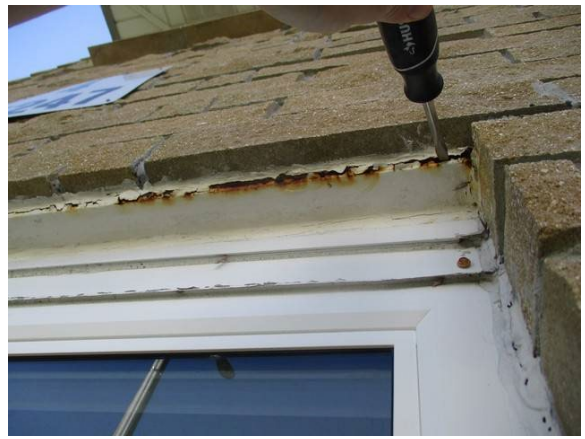
49 Left Side of Building Lintel Sag w/ Severe Corrosion
