Condominiums at Paradise Shores Long Term Maintenance Report

July 21, 2025

J. Scott Rasbach, Maintenance Director

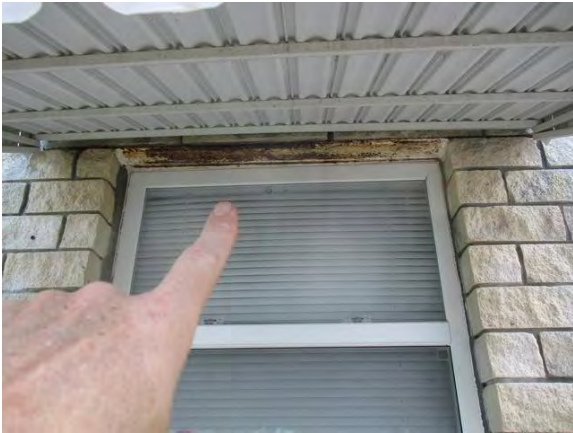
The deficiency observed is due to sagging or deflected metal lintels on the first floor, which have resulted in cracking within the fluted concrete block directly above these structural members. This failure has extended to the second floor, where noticeable and severe separation has occurred at certain window locations where the frames meet the block construction. Upon closer inspection, many of the affected lintels were found to exhibit heavy corrosion, including laminar (or stratified) corrosion—a condition where rust causes the steel to flake or separate in layers, significantly reducing the section size and compromising structural performance.

5 Front Left Lintel Sag w/ Severe Corrosion

For the lintels and adjacent masonry areas that are heavily damaged, Beryl recommends that temporary shoring be installed to safely support the structure above during repairs. Once shoring is in place, the damaged fluted block or brick masonry surrounding the lintels should be carefully removed. The corroded lintels should then be extracted and replaced with new corrosion-resistant

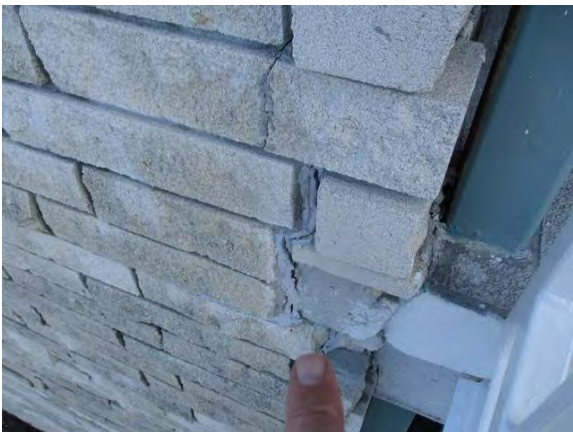
7 Front Left Fluted Block Cracking Between 1st & 2nd Floors

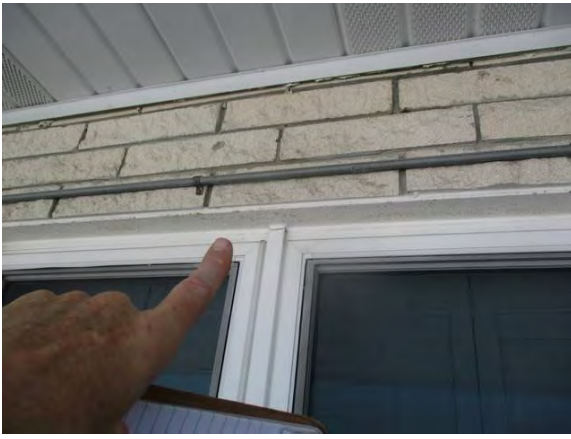
9 2nd Floor Walkway Lintels Minor Corrosion

In locations where the lintels show only slight corrosion—specifically noted at the first-floor front elevation under the walkway and around the perimeter of the second floor—Beryl recommends removal of all loose surface rust using a wire brush, grinder, or similar abrasive method. Once cleaned, the exposed metal should be treated with a rust-inhibiting primer, followed by the application of a high-performance protective paint or coating system designed for exterior steel. In areas where minor section loss has occurred, a structural-grade epoxy or metal filler compound should be used to restore uniformity and strength to the member. During these repairs, it is critical to inspect and ensure proper flashing and drainage above these areas to limit moisture exposure. Ongoing routine maintenance should be performed to monitor these lintels for signs of further deterioration and to apply protective coatings as needed over time.

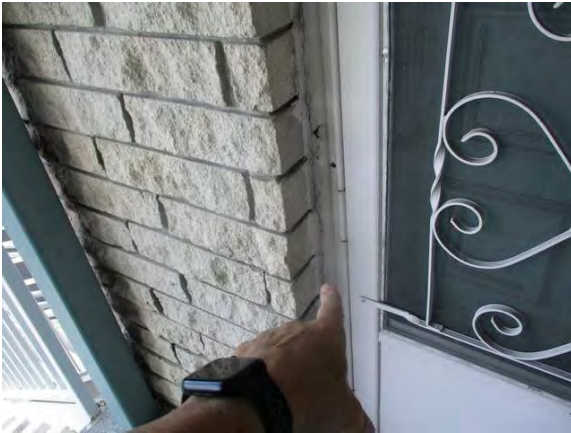
11 Door Caulking Deteriorated/Missing Throughout

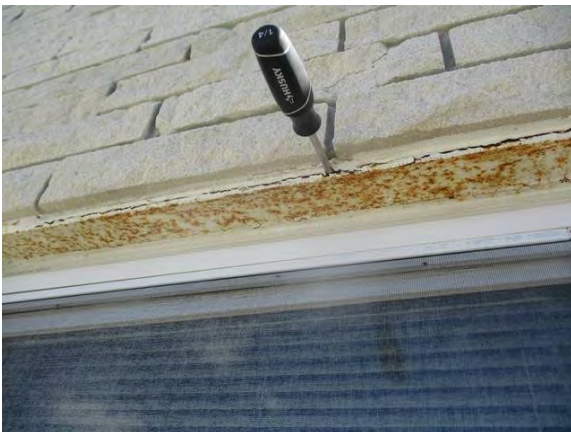
13 Front Right Lintel Sag w/ Severe Corrosion

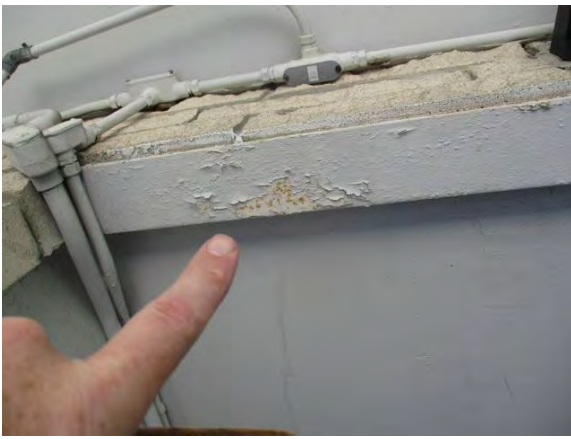
17 Hallway Lintel Minor Corrosion/Peeling Paint

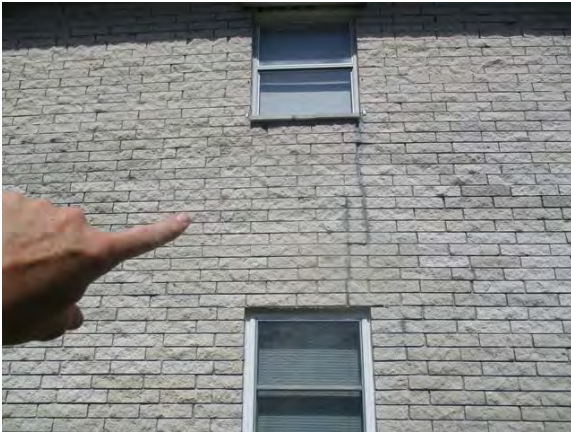
19 Right Side of Building Fluted Block Cracked Between 1st & 2nd Floors

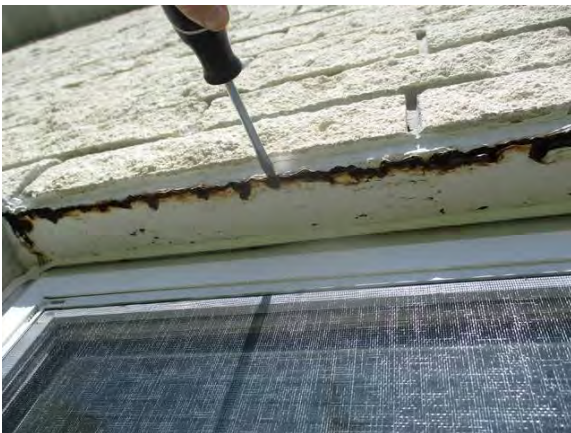
21 Right Side of Building Lintel Sag w/ Severe Corrosion

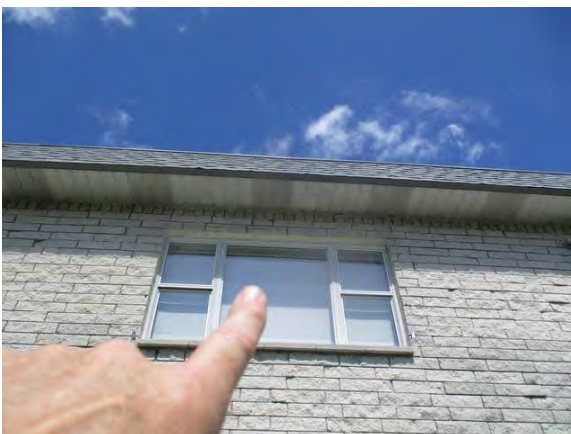
23 2nd Floor Lintels Minor Corrosion

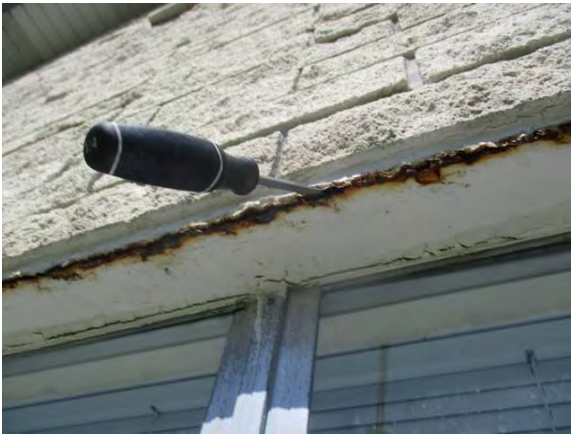
25 Right Side of Building Lintel Sag w/ Severe Corrosion

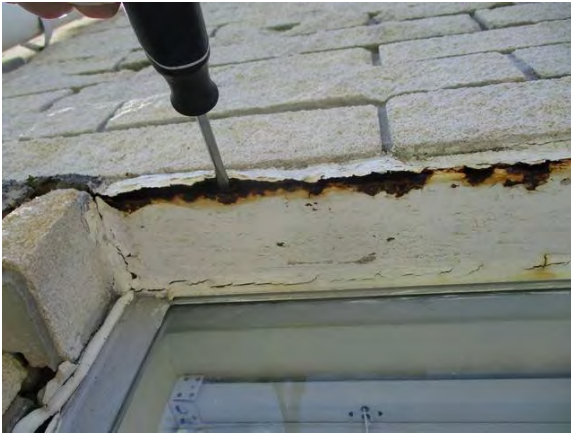
27 Rear of Building Lintel Sag w/ Severe Corrosion

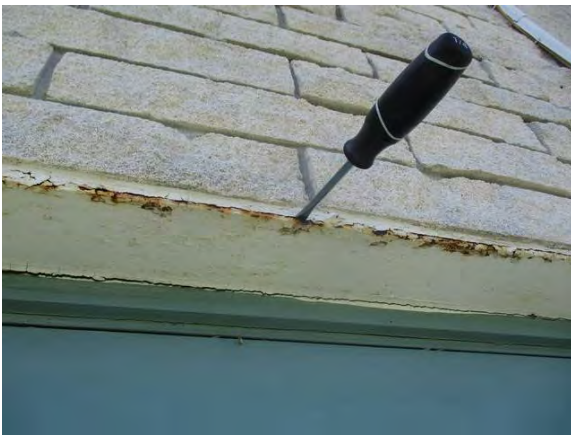
29 Rear of Building Lintel Sag w/ Severe Corrosion

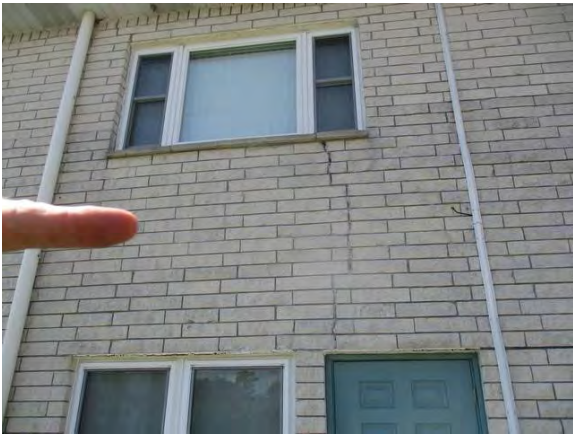
33 Rear of Building Fluted Block Cracked Between 1st & 2nd Floor

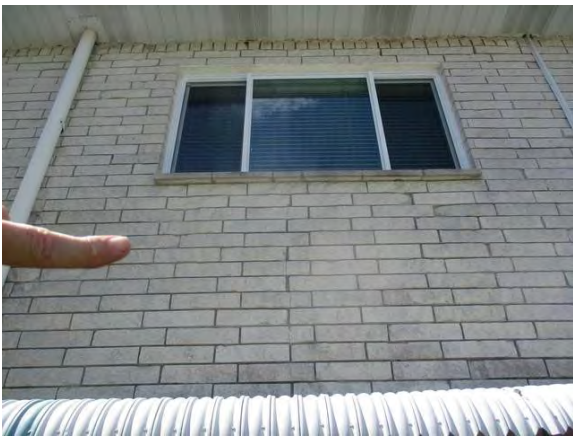
37 Rear of Building Fluted Block Cracked Between 1st & 2nd Floor

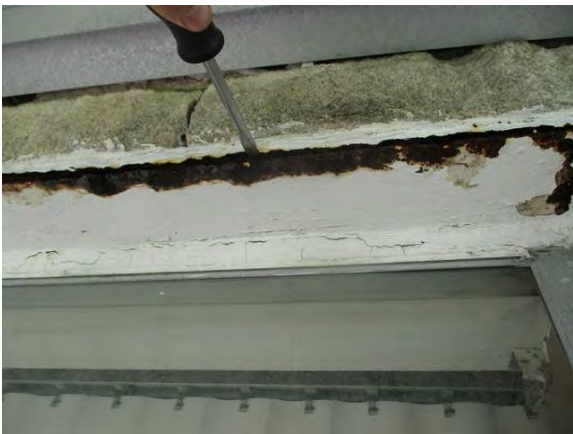
39 Rear of Building Lintel Sag w/ Severe Corrosion

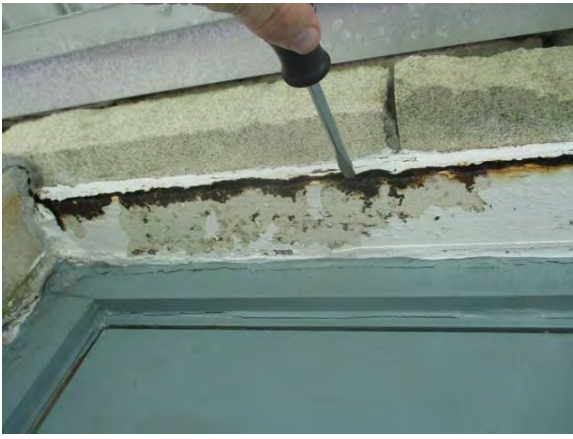
41 Rear of Building Lintel Sag w/ Severe Corrosion

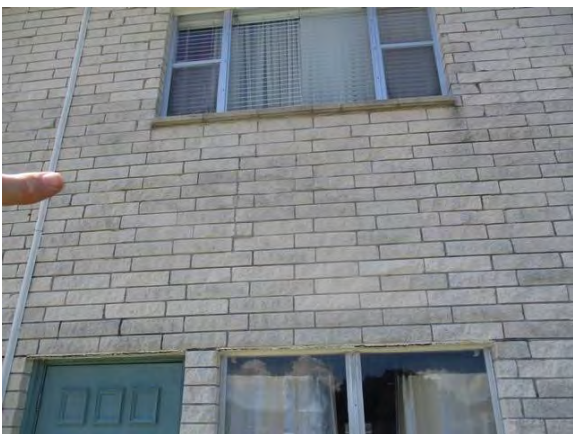
47 Rear of Building Fluted Block Cracked Between 1st & 2nd Floor

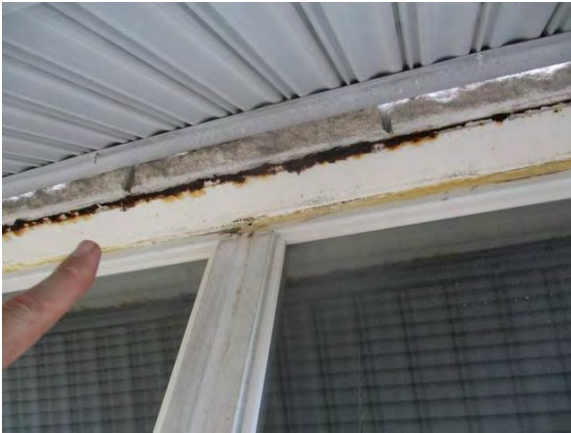
51 Left Side of Building Lintel Severe Corrosion

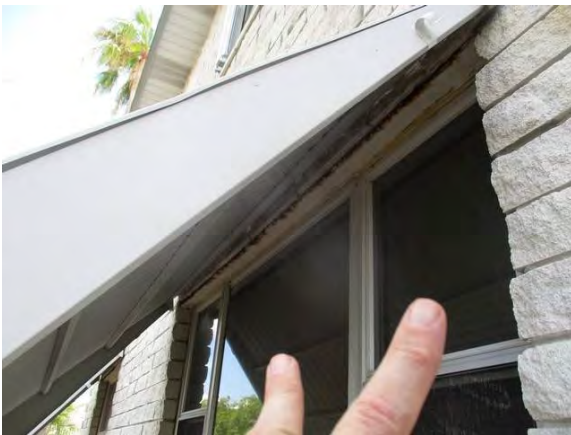
53 Left Side of Building Fluted Block Cracked Between 1st & 2nd Floor

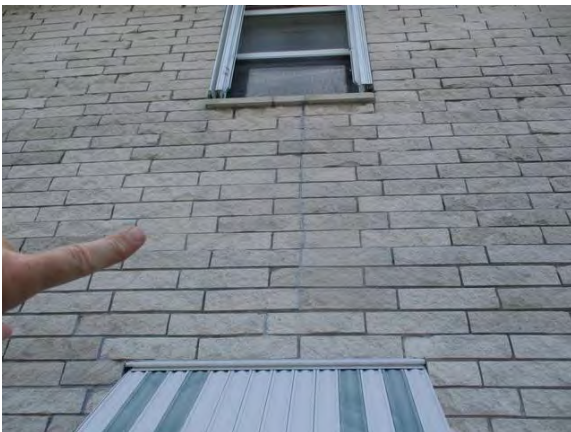
55 Left Side of Building Fluted Block Cracked Between 1st & 2nd Floor

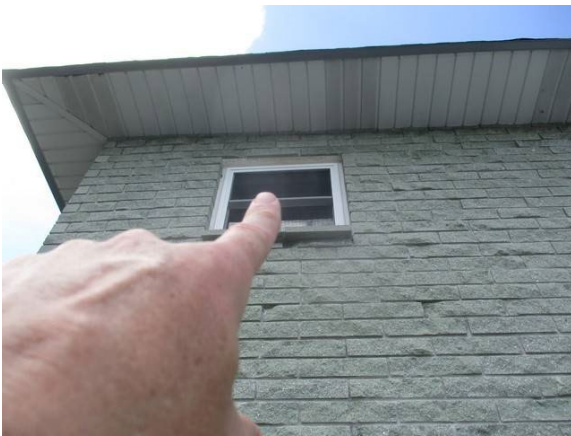
5 2nd Floor Lintels Minor Corrosion

In locations where the lintels show only slight corrosion—specifically noted at the first-floor front elevation under the walkway and around the perimeter of the second floor—Beryl recommends removal of all loose surface rust using a wire brush, grinder, or similar abrasive method. Once cleaned, the exposed metal should be treated with a rust-inhibiting primer, followed by the application of a high-performance protective paint or coating system designed for exterior steel. In areas where minor section loss has occurred, a structural-grade epoxy or metal filler compound should be used to restore uniformity and strength to the member. During these repairs, it is critical to inspect and ensure proper flashing and drainage above these areas to limit moisture exposure. Ongoing routine maintenance should be performed to monitor these lintels for signs of further deterioration and to apply protective coatings as needed over time.

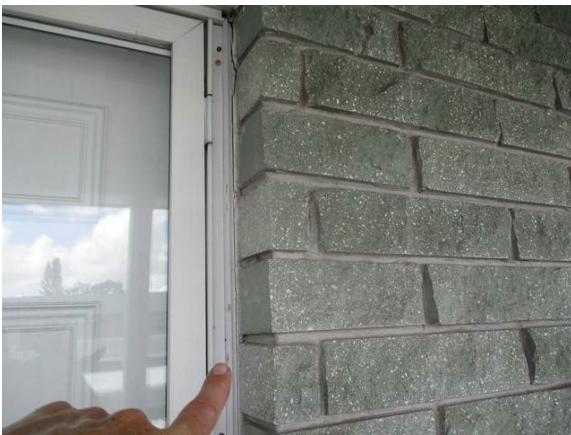
7 Door Caulking Deteriorated/Missing Throughout

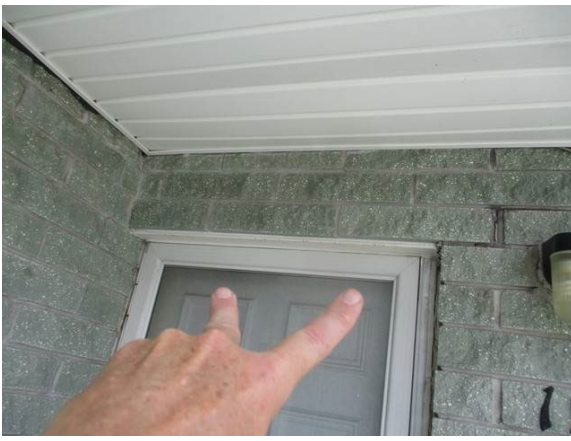
The deficiency observed is due to sagging or deflected metal lintels on the first floor, which have resulted in cracking within the fluted concrete block directly above these structural members. This failure has extended to the second floor, where noticeable and severe separation has occurred at certain window locations where the frames meet the block construction. Upon closer inspection, many of the affected lintels were found to exhibit heavy corrosion, including laminar (or stratified) corrosion—a condition where rust causes the steel to flake or separate in layers, significantly reducing the section size and compromising structural performance.

9 Unit #12 Lintel Sag w/ Fluted Block Cracking

For the lintels and adjacent masonry areas that are heavily damaged, Beryl recommends that temporary shoring be installed to safely support the structure above during repairs. Once shoring is in place, the damaged fluted block or brick masonry surrounding the lintels should be carefully removed. The corroded lintels should then be extracted and replaced with new corrosion-resistant

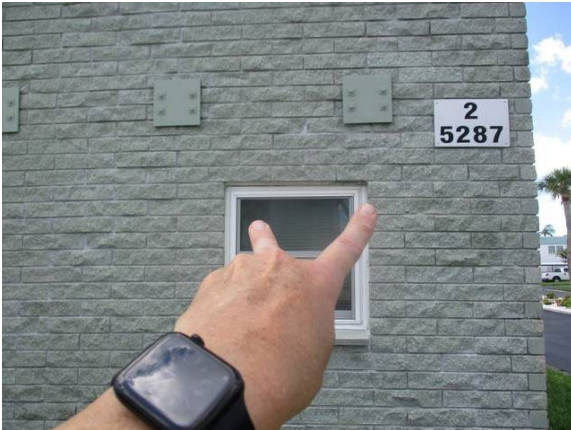
11 Front Right Lintel Sag w/ Severe Corrosion

It is essential that proper flashing and weep hole systems are installed or repaired during reconstruction to prevent future water infiltration, which is often a primary cause of corrosion in steel components. After installing the new lintels, the masonry should be rebuilt with materials that match the original in appearance and strength, using appropriate mortar and joint tooling. The masonry should be allowed adequate curing time before the temporary shoring is safely removed. Additionally, regular inspections should be scheduled as part of ongoing property maintenance, along with periodic repainting of exposed steel elements with corrosion-inhibiting coatings to preserve long-term durability.

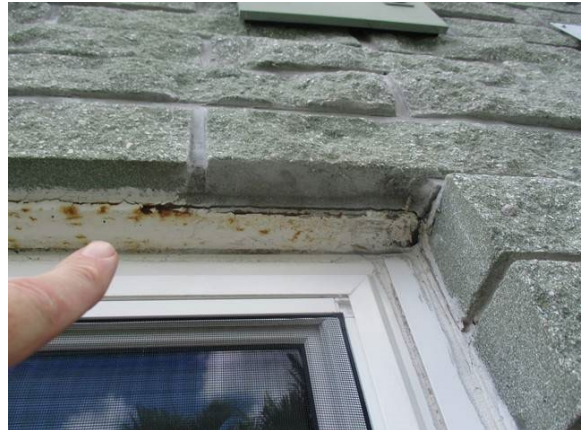
12 Front Right Lintel Sag w/ Severe Corrosion

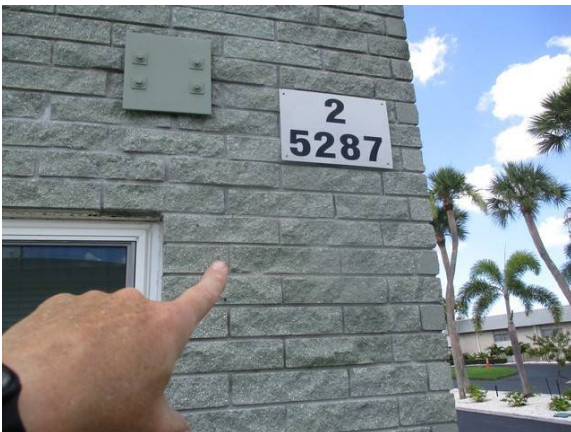
13 Front Right Fluted Block Cracked

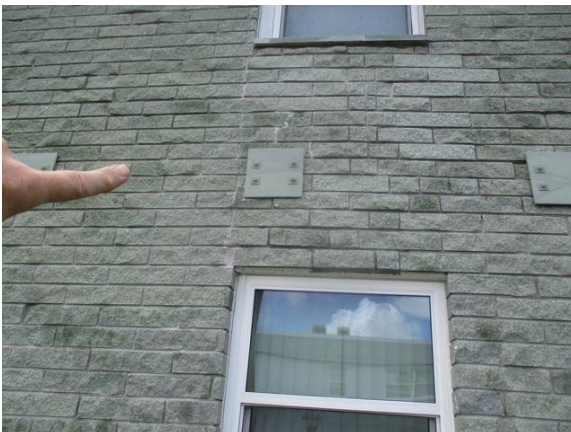
15 Right Side of Building Fluted Block Cracked Between 1st & 2nd Floors

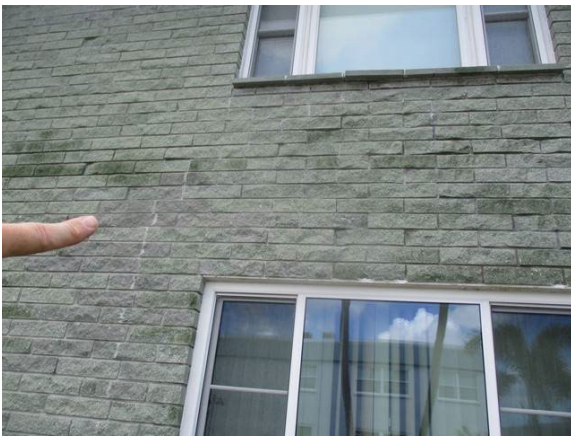
17 Right Side of Building Fluted Block Cracked Between 1st & 2nd Floors

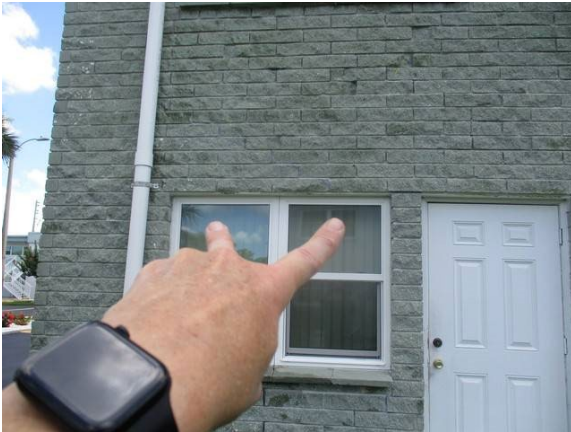
19 Rear of Building Lintel Sag w/ Severe Corrosion

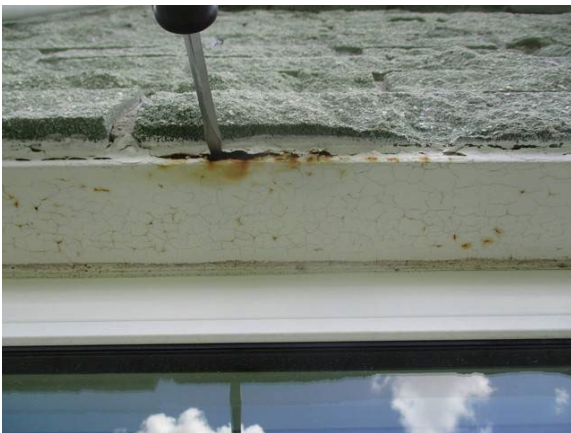
21 Rear of Building Lintel Sag w/ Severe Corrosion

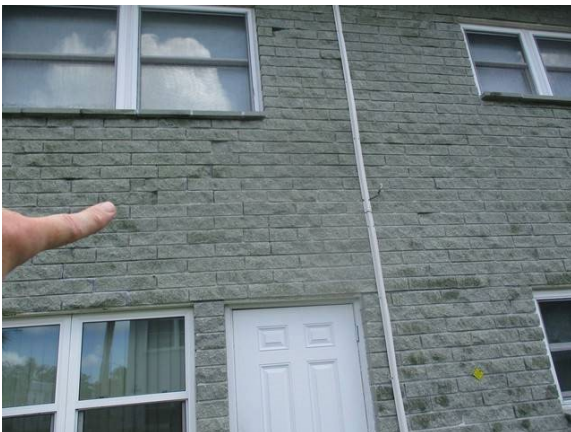
23 Rear of Building Fluted Block Cracked Between 1st & 2nd Floors

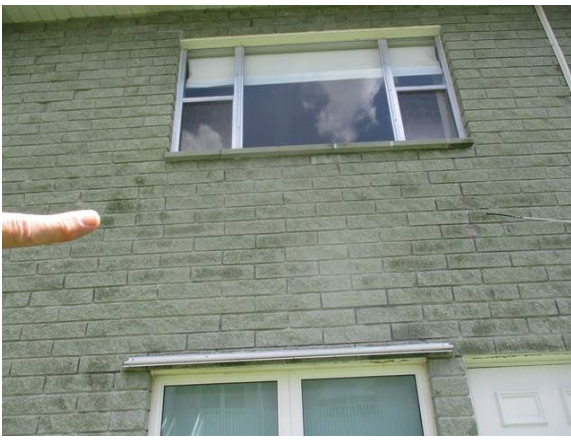
25 Rear of Building Fluted Block Cracked Between 1st & 2nd Floors

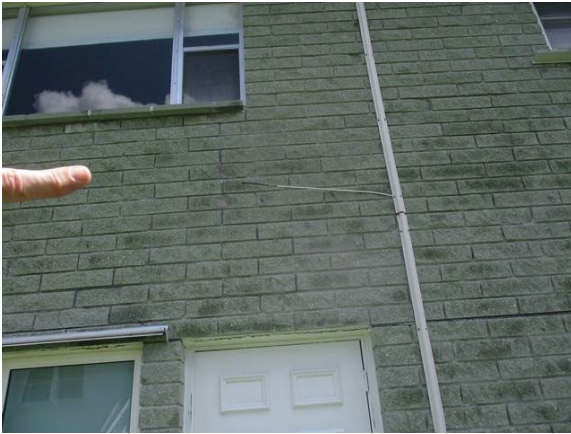
27 Rear of Building Fluted Block Cracked Between 1st & 2nd Floors

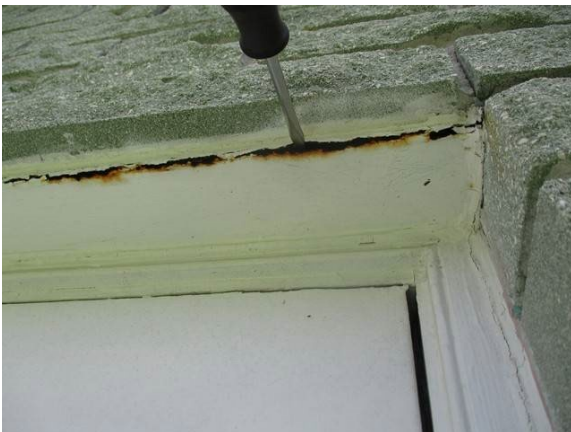
31 Rear of Building Lintel Sag w/ Severe Corrosion

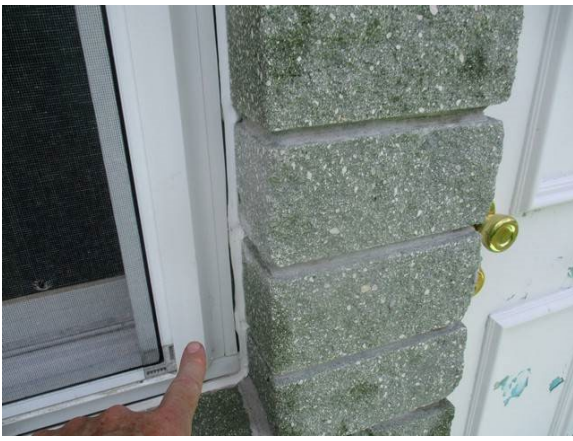
33 Window Caulking Deteriorated/Missing Throughout

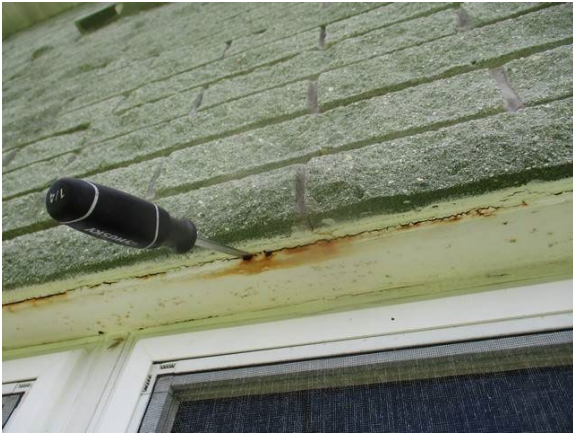
35 Rear of Building Lintel Sag w/ Severe Corrosion

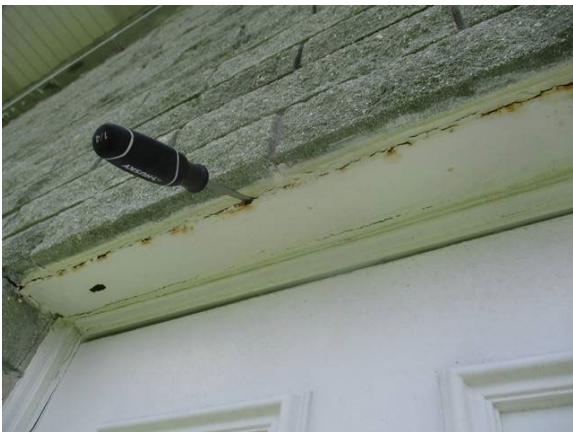
37 Rear of Building Lintel Sag w/ Severe Corrosion

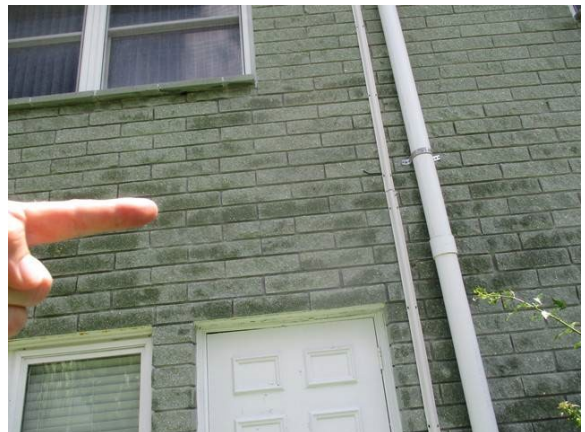
38 Rear of Building Fluted Block Cracked Between 1st & 2nd Floors

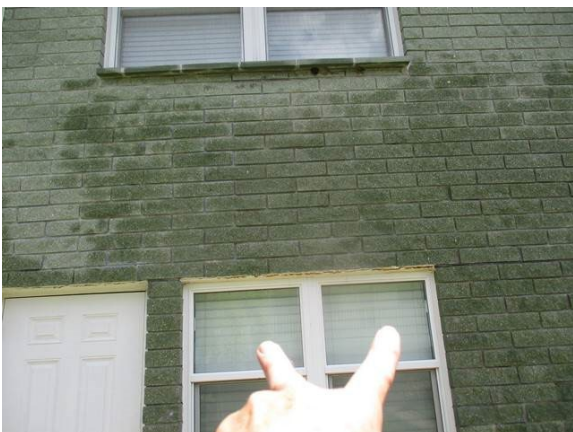
39 Rear of Building Lintel Sag w/ Severe Corrosion

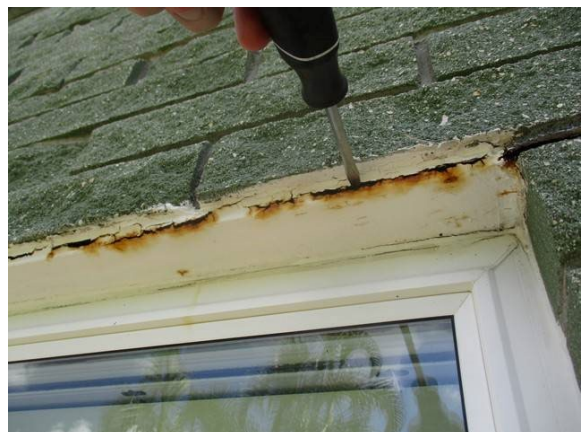
40 Rear of Building Lintel Sag w/ Severe Corrosion

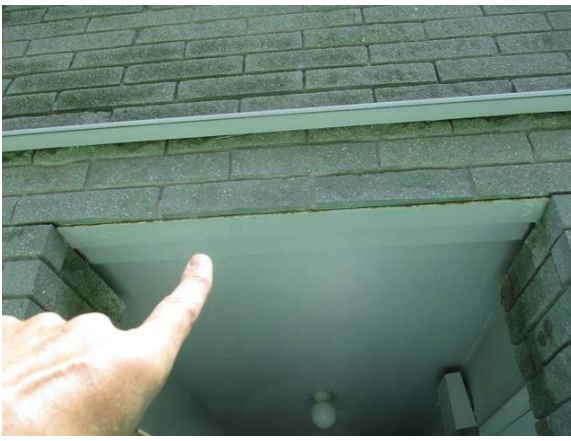
41 Hallway Lintel Minor Corrosion

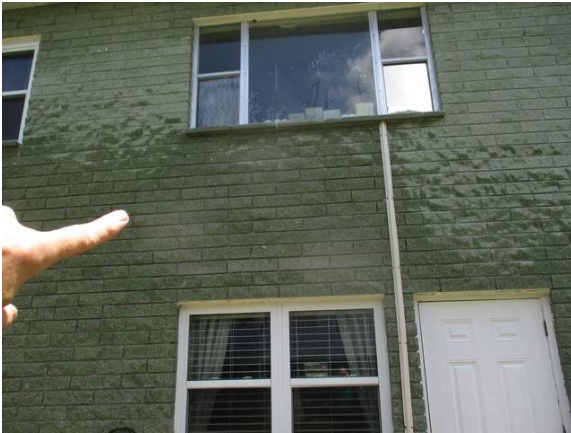
43 Rear of Building Fluted Block Cracked Between 1st & 2nd Floors

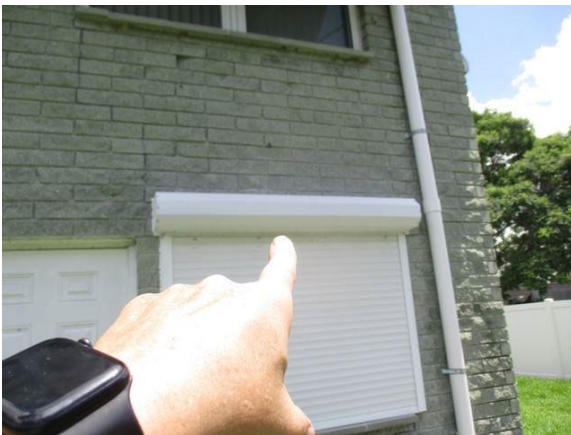
45 Unable To Inspect Rear Left Lintel Due To Roll Down Shutters

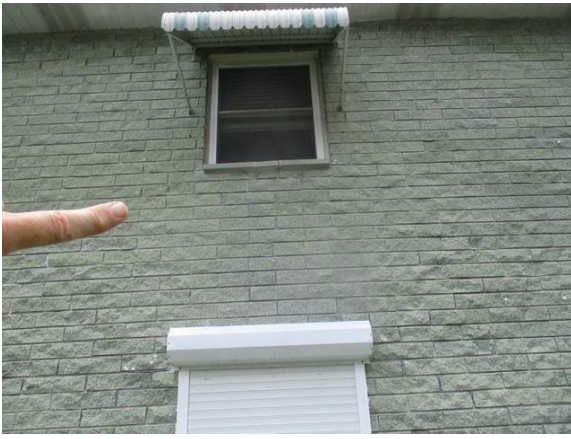
49 Left Side of Building Fluted Block Cracked Between 1st & 2nd Floors

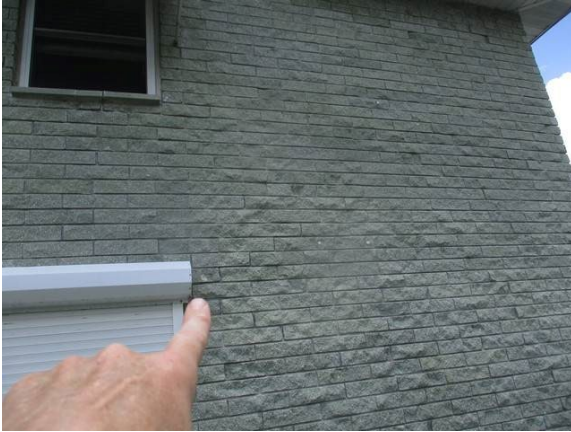
51 Left Side of Building Fluted Block Cracked Between 1st & 2nd Floors

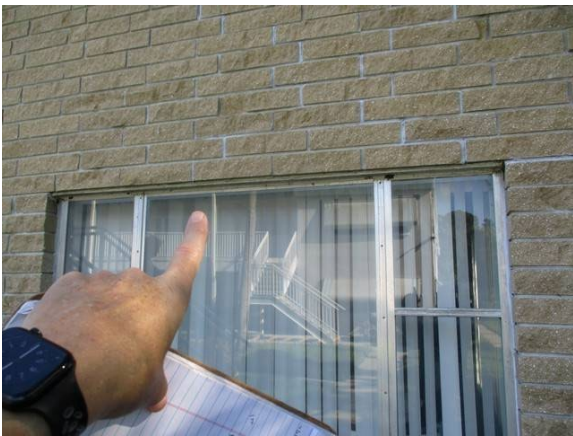
The deficiency observed is due to sagging or deflected metal lintels on the first floor, which have resulted in cracking within the fluted concrete block directly above these structural members. This failure has extended to the second floor, where noticeable and severe separation has occurred at certain window locations where the frames meet the block construction. Upon closer inspection, many of the affected lintels were found to exhibit heavy corrosion, including laminar (or stratified) corrosion—a condition where rust causes the steel to flake or separate in layers, significantly reducing the section size and compromising structural performance.

5 Front Right #13 Lintel Sag

For the lintels and adjacent masonry areas that are heavily damaged, Beryl recommends that temporary shoring be installed to safely support the structure above during repairs. Once shoring is in place, the damaged fluted block or brick masonry surrounding the lintels should be carefully removed. The corroded lintels should then be extracted and replaced with new corrosion-resistant

It is essential that proper flashing and weep hole systems are installed or repaired during reconstruction to prevent future water infiltration, which is often a primary cause of corrosion in steel components. After installing the new lintels, the masonry should be rebuilt with materials that match the original in appearance and strength, using appropriate mortar and joint tooling. The masonry should be allowed adequate curing time before the temporary shoring is safely removed. Additionally, regular inspections should be scheduled as part of ongoing property maintenance, along with periodic repainting of exposed steel elements with corrosion-inhibiting coatings to preserve long-term durability.

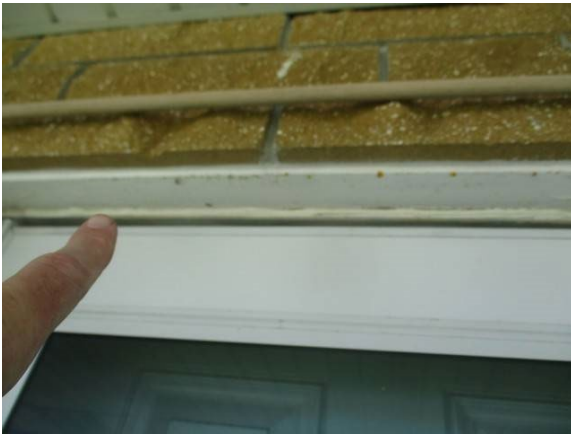
9 Lintels 2nd Floor Walkway Minor Corrosion

In locations where the lintels show only slight corrosion—specifically noted at the first-floor front elevation under the walkway and around the perimeter of the second floor—Beryl recommends removal of all loose surface rust using a wire brush, grinder, or similar abrasive method. Once cleaned, the exposed metal should be treated with a rust-inhibiting primer, followed by the application of a high-performance protective paint or coating system designed for exterior steel. In areas where minor section loss has occurred, a structural-grade epoxy or metal filler compound should be used to restore uniformity and strength to the member. During these repairs, it is critical to inspect and ensure proper flashing and drainage above these areas to limit moisture exposure. Ongoing routine maintenance should be performed to monitor these lintels for signs of further deterioration and to apply protective coatings as needed over time.

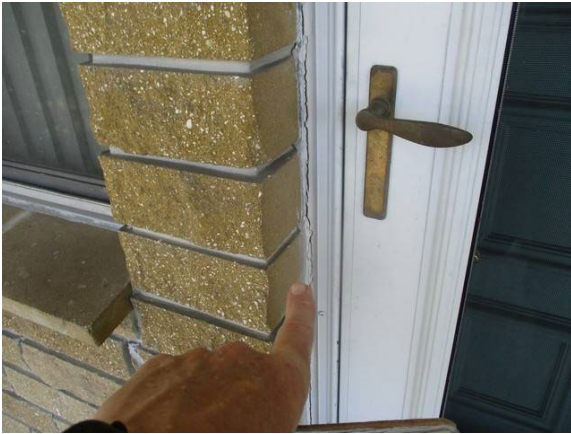
11 Caulking Deteriorated/Missing Doors Throughout

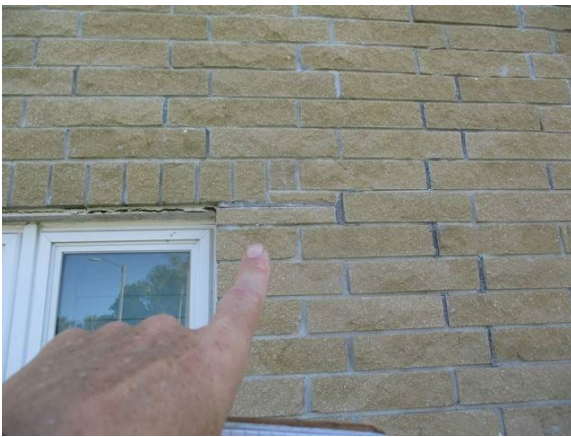
13 Front Left Lintel Sag w/ Excessive Corrosion Fluted Block Cracking

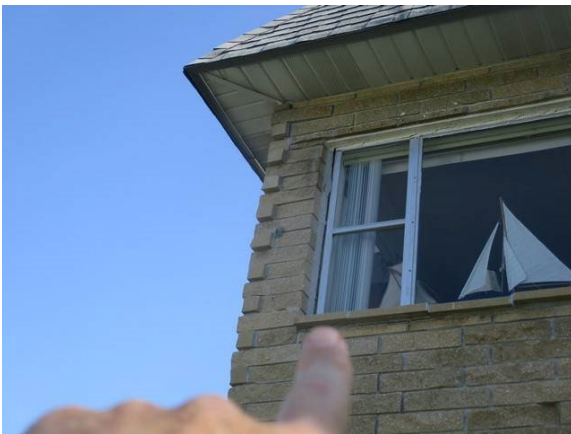
15 Front Left 2nd Floor Window Separation

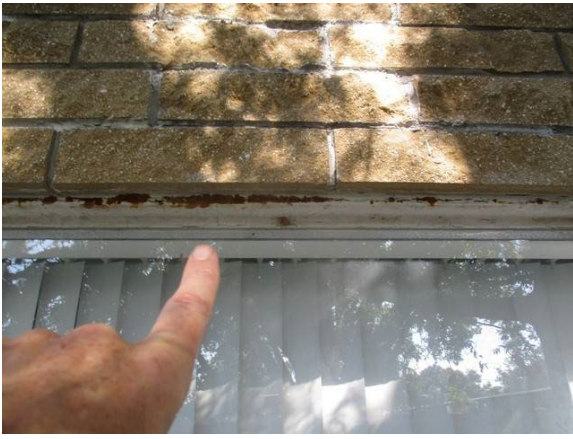
17 Right Side 1st Floor Lintel Severe Corrosion

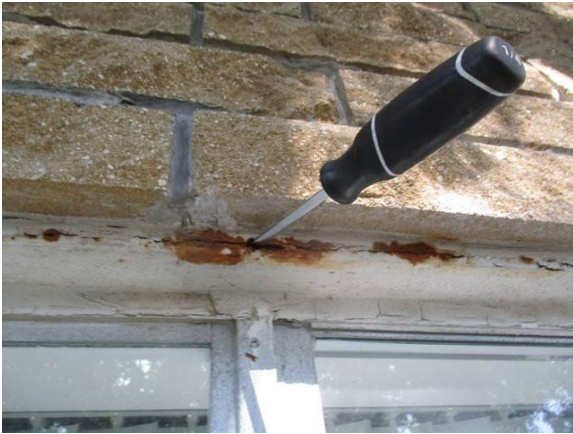
19 Right Side 1st Floor Lintel Severe Corrosion

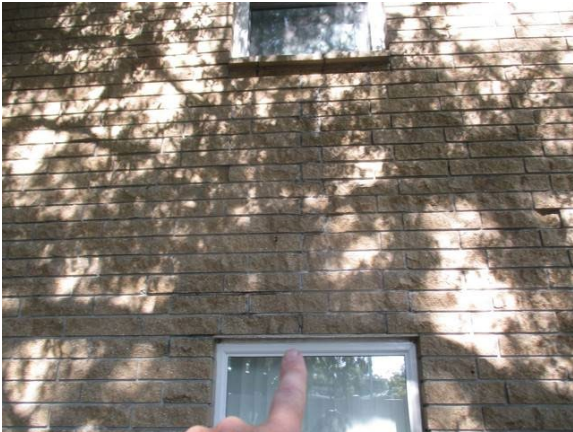
21 Right Side 1st Floor Lintel Severe Corrosion w/ Sag

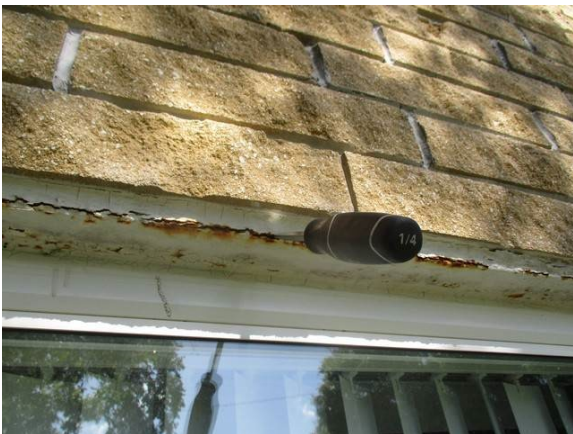
23 Right Side 1st Floor Lintel Severe Corrosion

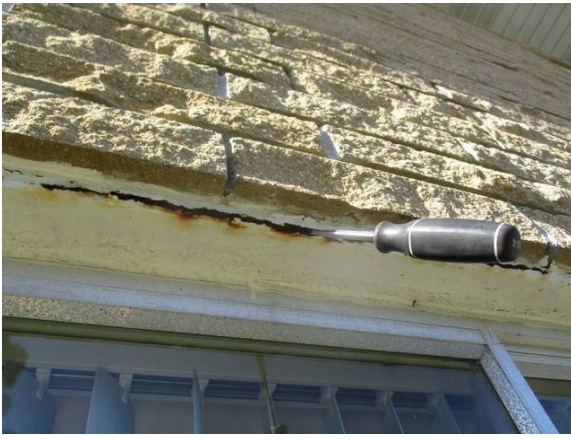
25 Rear of Building Lintel Severe Corrosion w/ Sag

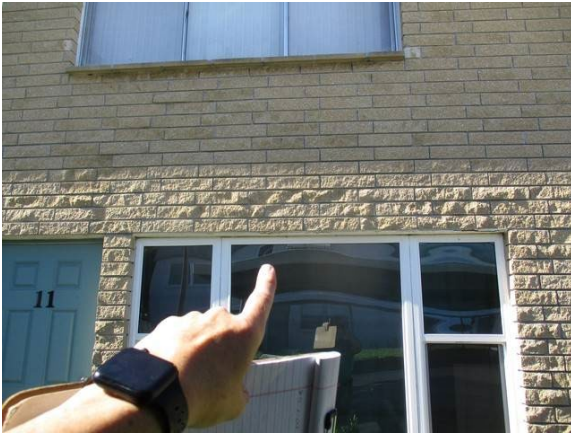
27 Rear of Building Lintel Severe Corrosion w/ Sag

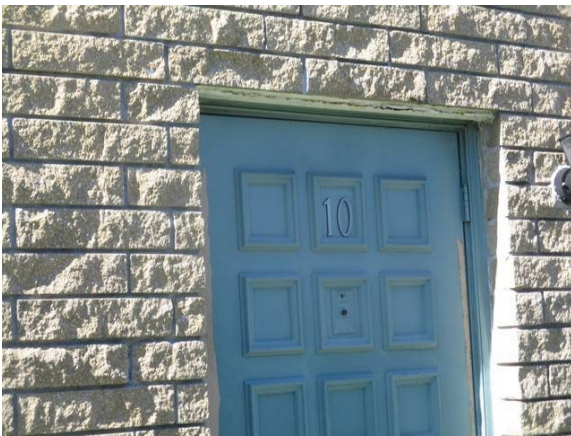
28 Rear of Building Lintel Severe Corrosion w/ Sag

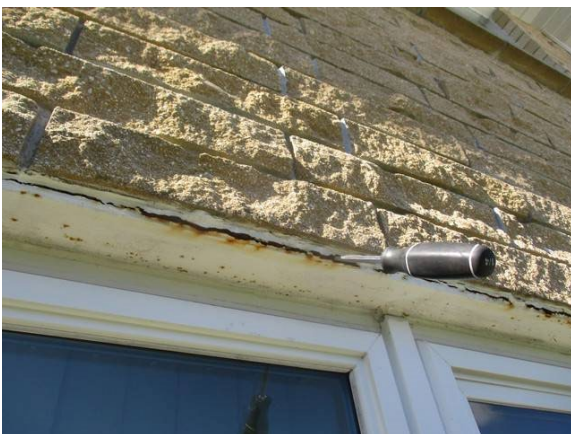
30 Rear of Building Lintel Severe Corrosion w/ Sag

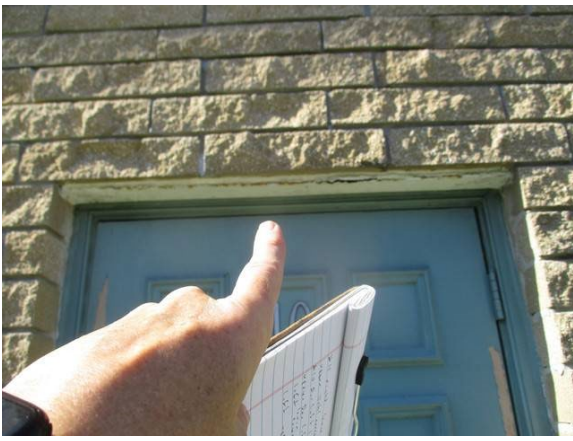
32 Rear of Building 2nd Floor Lintels Minor Corrosion

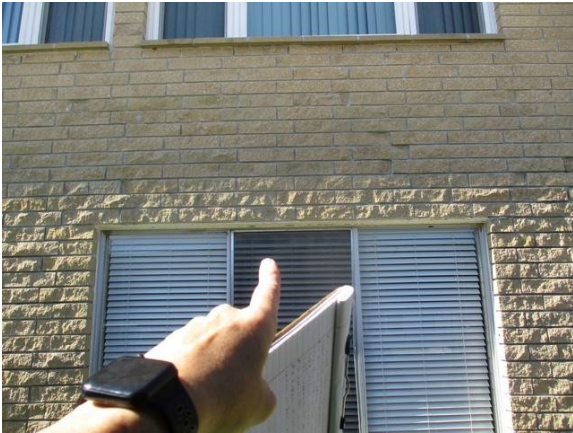
34 Rear of Building Lintel Severe Corrosion w/ Sag

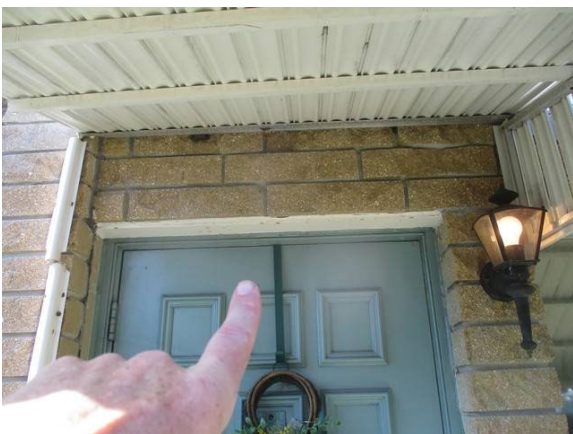
38 Rear of Building Lintel Sag w/ Severe Corrosion

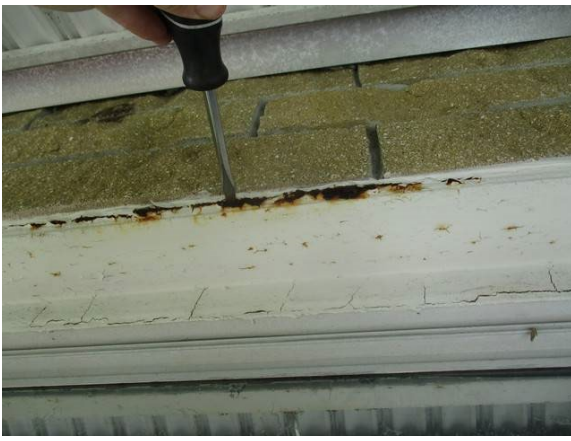
40 Rear of Building Lintel Sag w/ Severe Corrosion

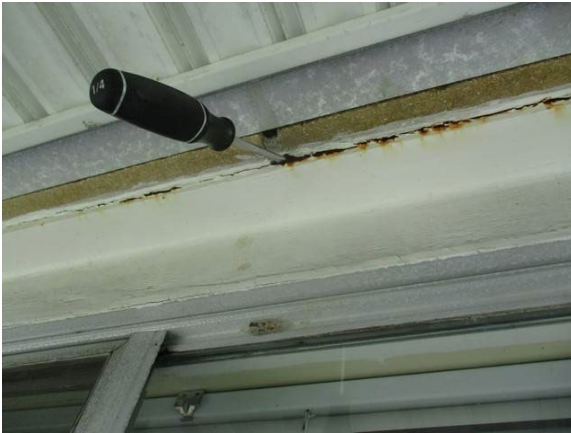
42 Rear of Building Lintel Sag w/ Severe Corrosion

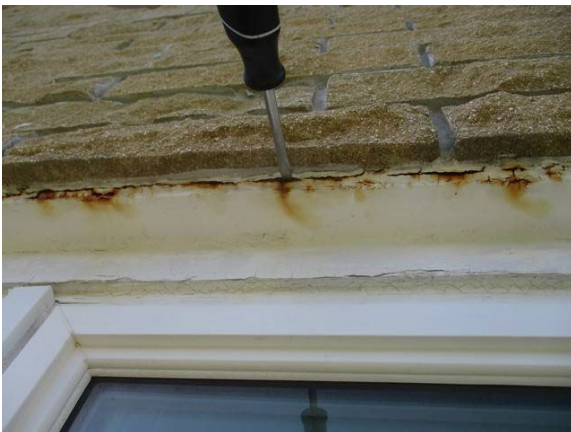
44 Rear of Building Lintel Sag w/ Severe Corrosion

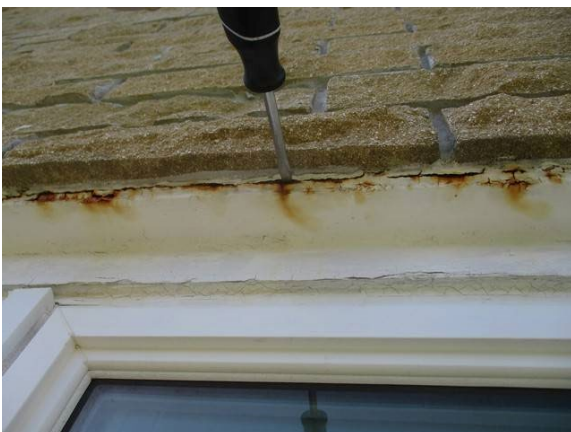
46 Rear of Building Lintel Sag w/ Severe Corrosion

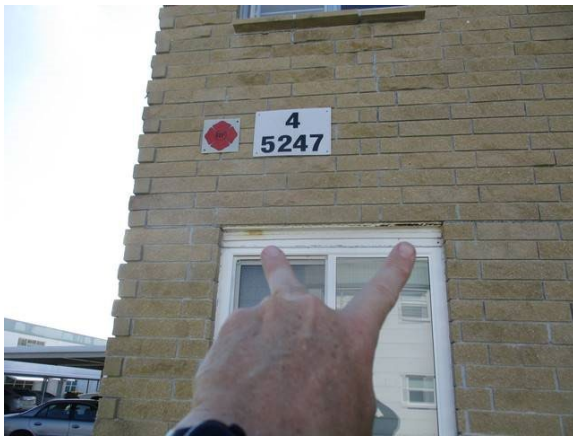
48 Left Side of Building 2nd Floor Lintels Minor Corrosion

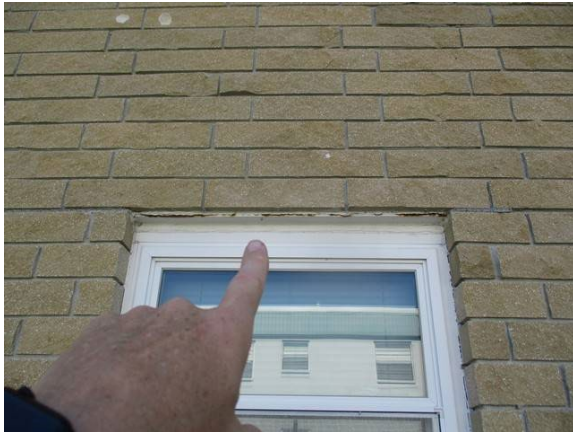
50 Left Side of Building Lintel Sag w/ Severe Corrosion

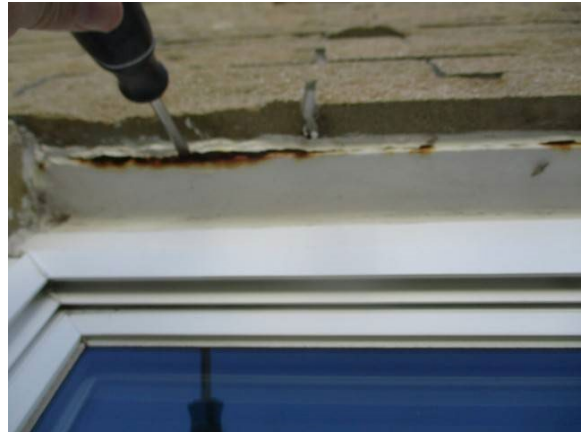
51 Left Side of Building Lintel Sag w/ Severe Corrosion

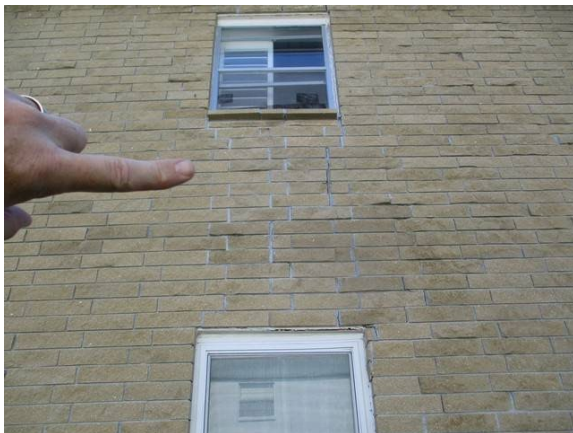
52 Left Side of Building Lintel Sag w/ Severe Corrosion

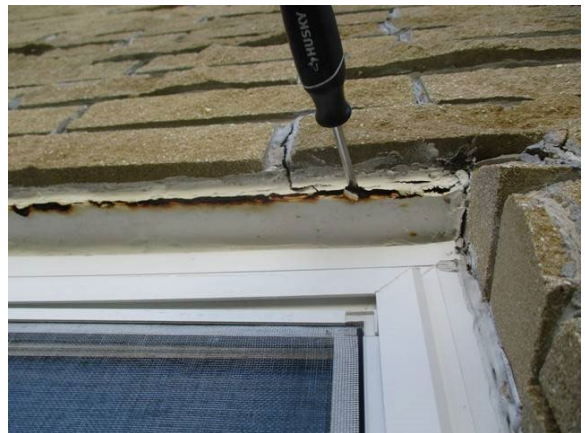
53 Left Side of Building Fluted Block Cracking Between 1st & 2nd Floor
